Schoharie Creek Management Unit 17

Town of Prattsville – Station 19376 to NYS Route 23 Bridge (Station 10486)

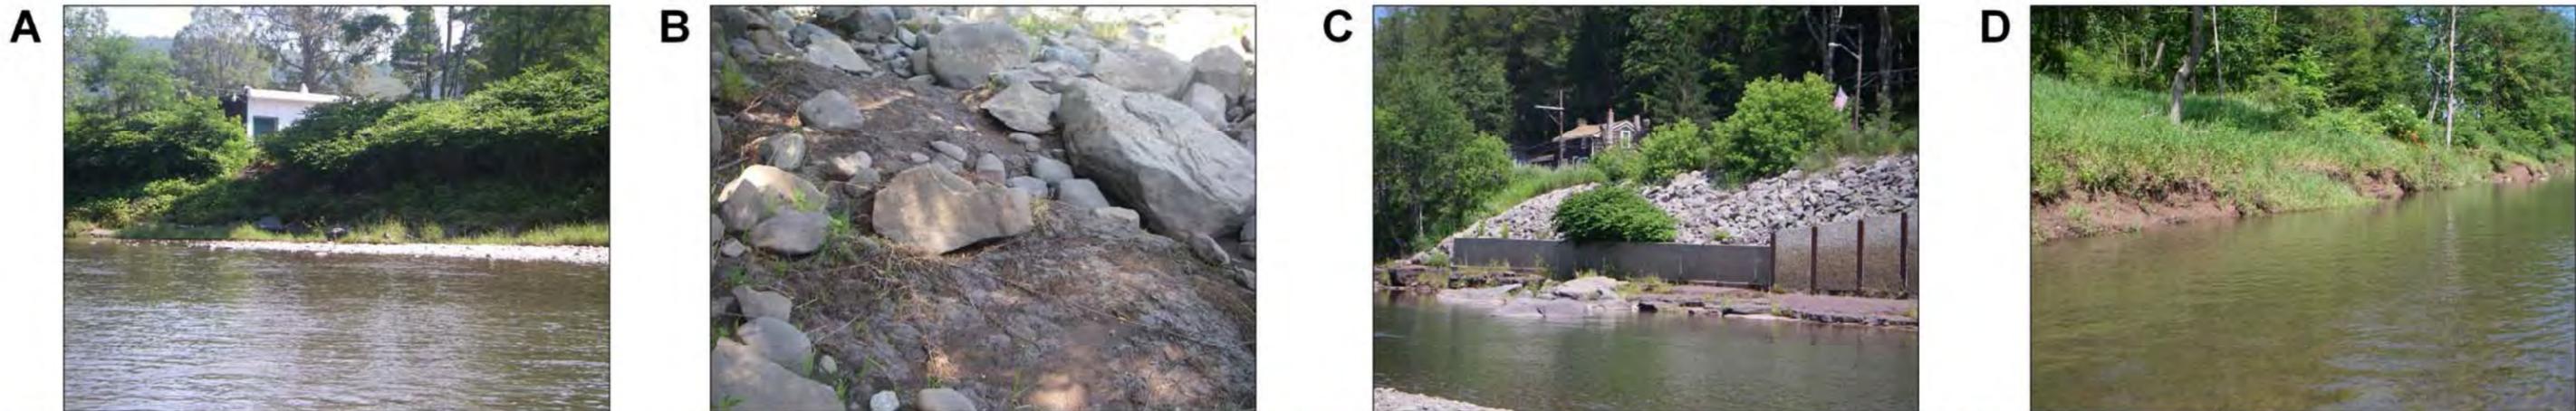
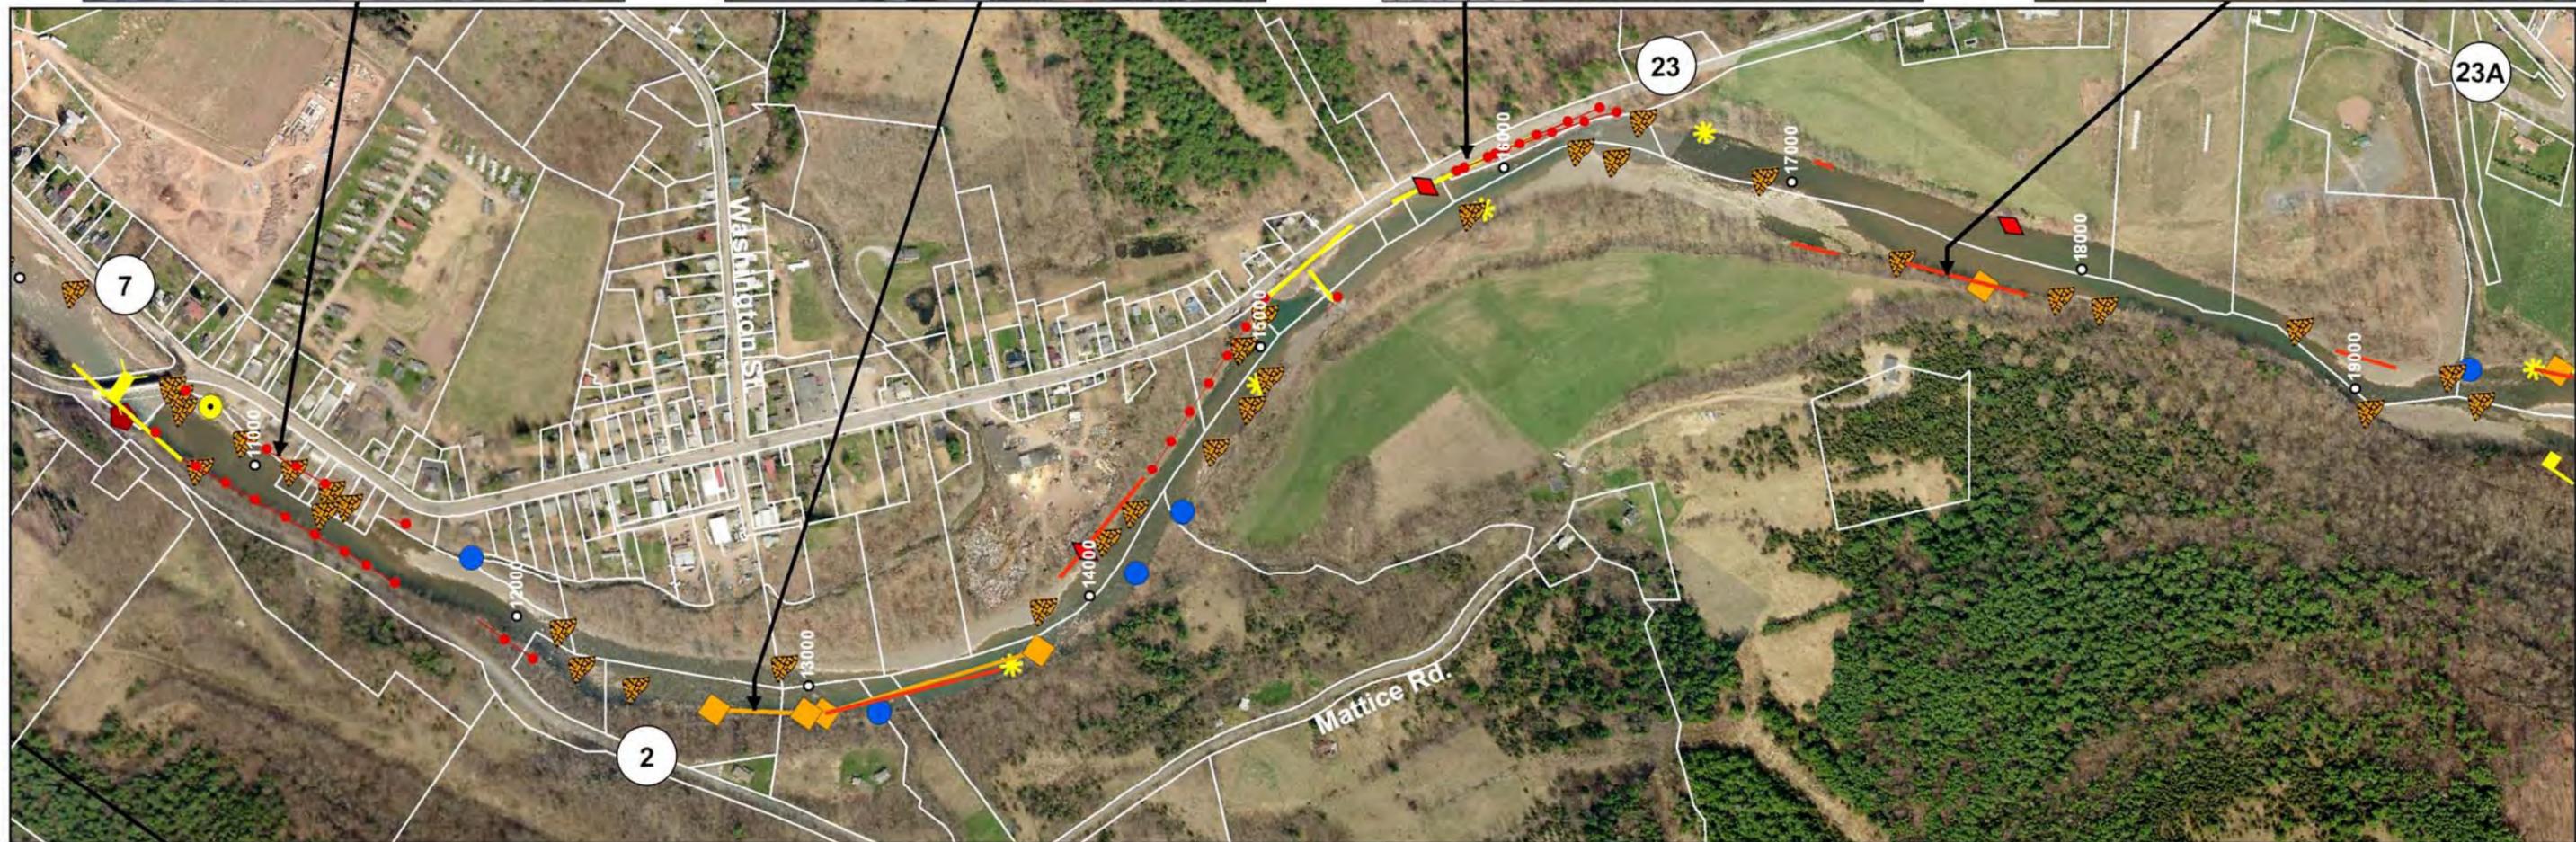
Figure 4.17.1 Management Unit 17 - 2006 aerial photography with stream feature inventory

The 2006 stream feature inventory revealed that 10.6% (1,888 ft) of the streambanks exhibited signs of active erosion along the 17,779 ft of total channel length in the unit (Figure 4.17.1). The total surface area of active erosion totaled approximately 15,754 ft². *Revetment* has been installed on 18.7% (3,328 ft) of the streambanks. No *berms* were identified in this management unit at the time of the stream feature inventory.

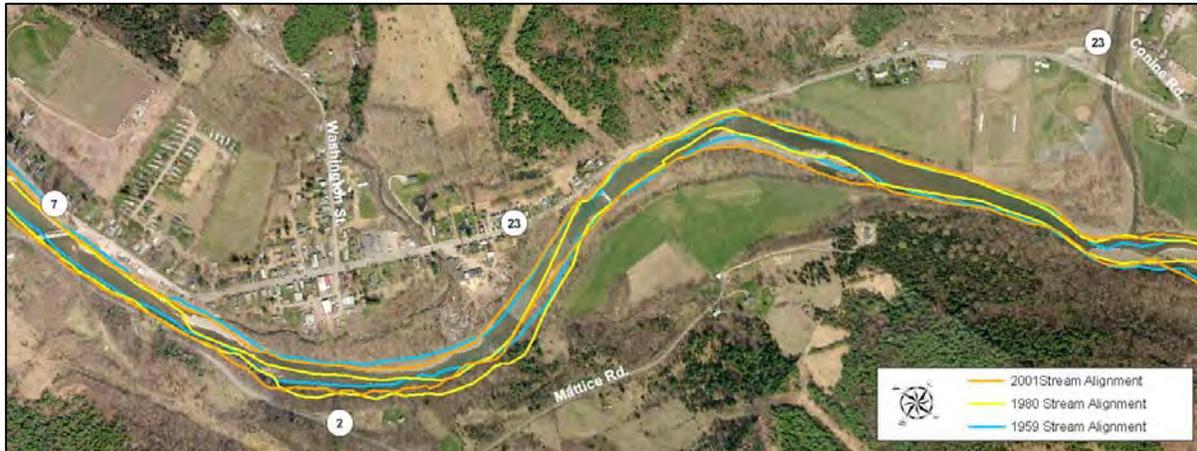
As seen from the historical stream alignments (below), the *planform* of the channel has remained fairly stable since 1959.

Historic stream channel alignments overlaid with 2006 aerial photograph

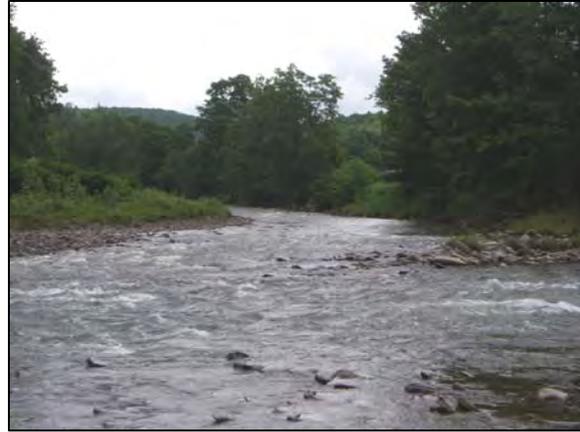
Schoharie Creek at approximately 1,600 feet. As a result of this topography change, the tributary lost its ability to transport sediment gathered from the Batavia Kill Watershed, and began to deposit sediment at its mouth and into the Schoharie Creek. This is a common feature of confluence areas, which often contain extensive sediment bars, function as important sediment storage areas and are typically among the most

Batavia Kill tributary - looking upstream

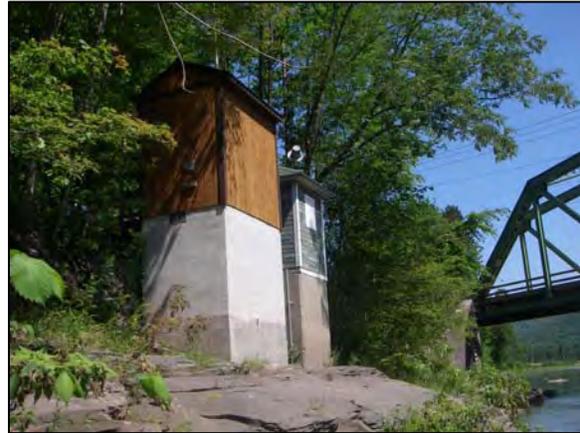
A United States Geologic Survey (USGS) continuously recording stream gage was located on the left streambank approximately 100 ft upstream from the NYS Route 23 bridge in Prattsville (Station 10600). This gage (#01350000) has a drainage area of 237 mi² and has been collecting data from November 1902 to the present. All gage information including real time discharge and gage height is available online at the USGS website:

USGS stream gage #01350000 at State Route 23 bridge in Prattsville - Station 10600

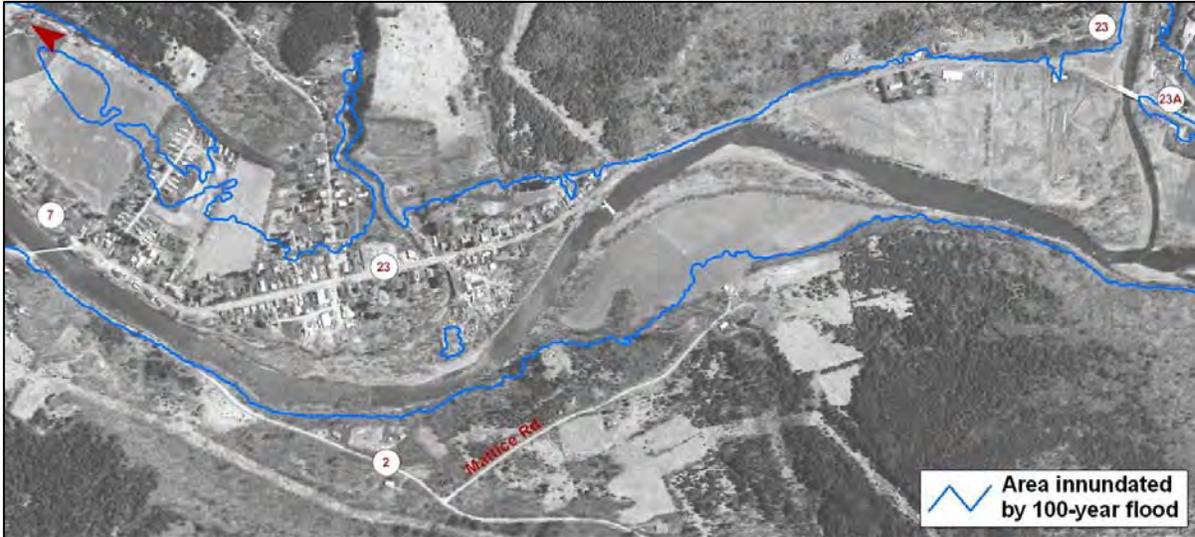
100-year floodplain boundary map

According to the current floodplain maps (above), one hundred sixty-five existing structures in this unit appeared to be situated within the estimated 100-year floodplain. The 100-year floodplain is that area predicted to be inundated by floods of a magnitude that are expected to occur once in any 100-year period, on the basis of a statistical analysis of local
