Neversink River East Branch

MANAGEMENT UNIT 1

EAST BRANCH MANAGEMENT UNIT 1
BETWEEN STATION 1450 AND STATION 0

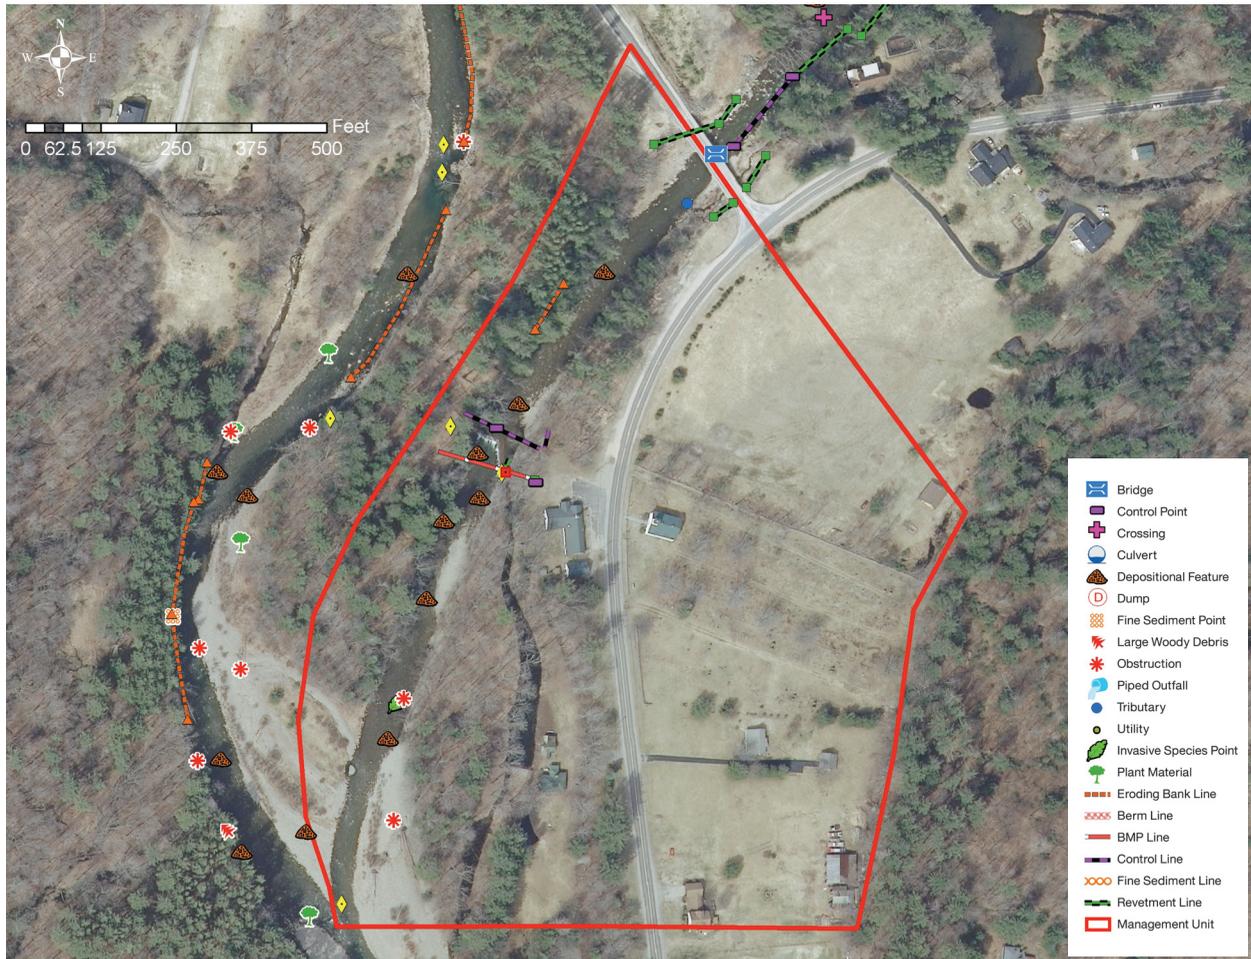
Stream Feature Inventory 2010 (Figure 1)

- 3% of stream length is experiencing erosion
- 4.87% of stream length has been stabilized
- 13.60 acres of inadequate vegetation within the riparian buffer
- None of the stream length is within 50 ft. of the road
- 1 structure is located within the 100-year floodplain boundary

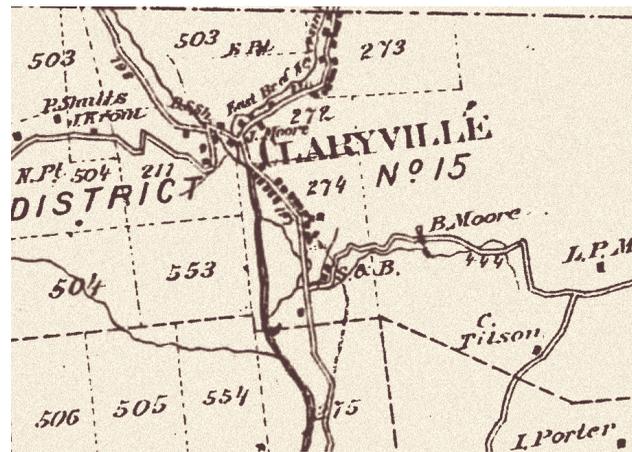
Excerpt from 1875 Beers Map (Figure 2)

The 1875 Beers Atlas of this area indicates that by that time, the stream had been harnessed for manufacturing, primarily saw mills, woodworking shops and tanneries (Figure 2). Raceways were built in the floodplains to divert water to ponds for use as needed. Floodplains were profoundly altered in the process, as these watercourses also became areas of preferential channelized flow when floodwaters inundated the floodplains. When woody debris jams blocked the primary channels, these raceways sometimes eroded out to become major secondary channels, or even took over the full flow to become a new primary watercourse.
