# Neversink River West Branch

## MANAGEMENT UNIT 9

WEST BRANCH MANAGEMENT UNIT 9  
BETWEEN STATION 32100 AND STATION 34300

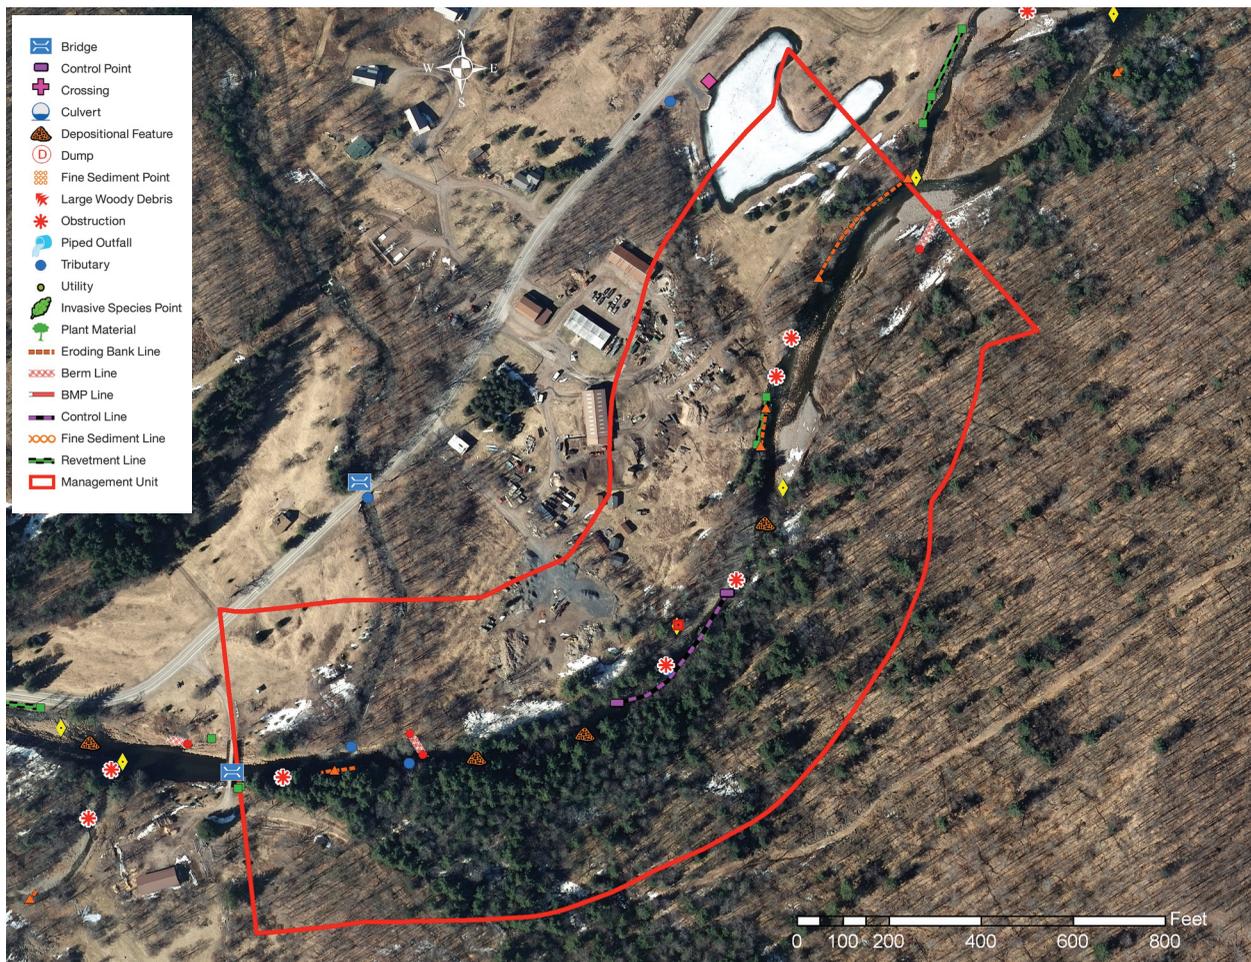
Stream Feature Inventory 2010 (Figure 1)

- 10.00% of stream length is experiencing erosion
- 2.38% of stream length has been stabilized
- 7.10 acres of inadequate vegetation within the 100 ft. buffer
- None of stream is within 50 ft. of the road
- There are two building structures located within the 100-year floodplain boundary

floodplain numerous times in many locations. A comparison of historical channel alignments (*Figure 3*) and in-stream observations made during a stream feature inventory in 2010 (*Figure 1, page 1*) indicate significant lateral channel instability. According to records available from the NYSDEC DART database twenty-seven NYS Article 15 stream disturbance permits have been issued in this management unit. These permits pertain to activities which have the potential to significantly impact stream function, such as bank stabilization, stream crossings, habitat enhancement, and logging practices. database (<http://www.dec.ny.gov/cfm/xtapps/envapps/>).

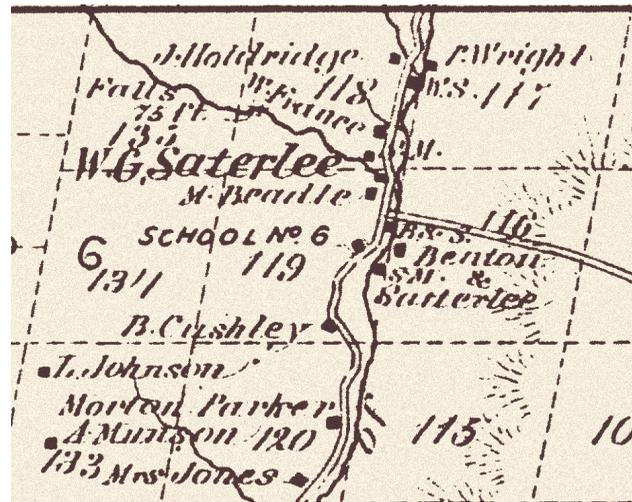
Excerpt from 1875 Beers Map (Figure 2)

The 1875 Beers Atlas of this area indicates that by that time, the stream had been harnessed for manufacturing, primarily saw mills, woodworking shops and tanneries (Figure 2). Raceways were built in the floodplains to divert water to ponds for use as needed. Floodplains were profoundly altered in the process, as these watercourses also became areas of preferential channelized flow when floodwaters inundated the floodplains. When woody debris jams blocked the primary channels, these raceways sometimes eroded out to become major secondary channels, or even took over the full flow to become a new primary watercourse.
