Management Unit 3
Greene County - Town of Hunter
Cross Section 34 to Cross Section 65

Management Unit Description

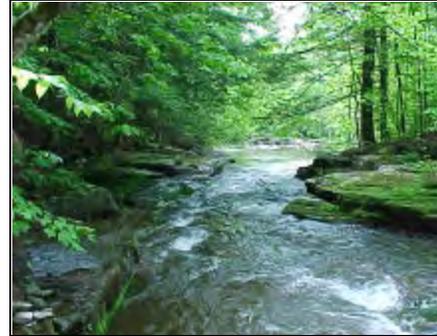
**Figure 4 Cross-section 36
Stream Type F1b**

Management unit #3 begins just downstream of cross-section 34 as the stream is transitioning from a B3c stream type into F1b (Fig. 4). This 280 ft. reach is *entrenched* with a wide bedrock stream channel, which is fast and shallow.

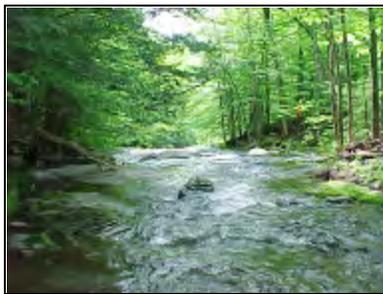
**Figure 7 Cross-section 38
Stream Type F3b**

As the stream emerges from the pool, it turns slightly, moving away from NYS Rt. 214. Stream type changes to F3b for the next 129 ft. reach (Fig. 7). The stream once again becomes entrenched and the stream widens. The slope increases to 2.6%.

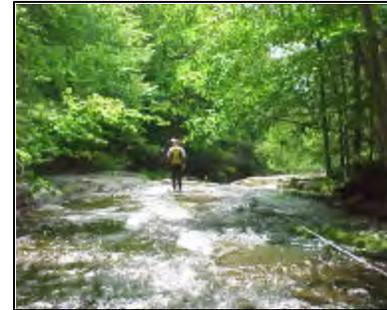
**Figure 8 Cross-section 39
Stream Type B1a**

Proceeding downstream, stream type changes to B1a (Fig. 8). This short 63 ft. reach is moderately entrenched with a wide bedrock stream channel. Slope increases dramatically to 4.6%.

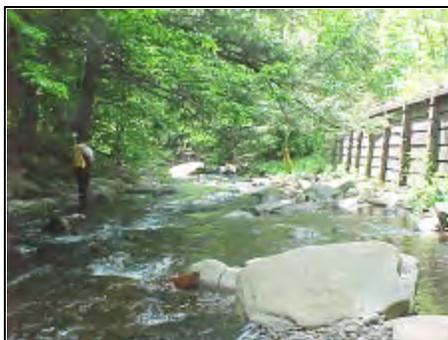
**Figure 11 Cross-section 41
Stream Type F3b**

As this reach ends, the channel becomes entrenched, changing to an F3b stream type for the next 306 ft. (Fig.11). The T-wall continues along the right bank for half of this reach, where it ends as the stream begins to meander away from NYS Route 214.

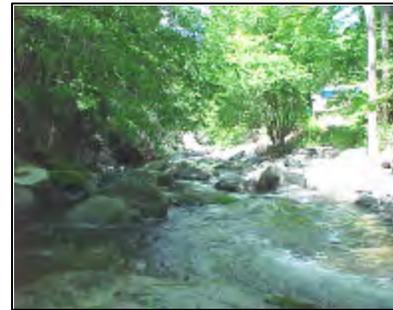
**Figure 13 Cross-section 44
Stream Type F3b**

The next 84 ft. of stream is classified as F3b (Fig. 13). Although the dominant bed material size changes to large cobble, there is still a significant amount of bedrock in the channel and along the left bank. This stream reach is entrenched and slope decreases to 4%.

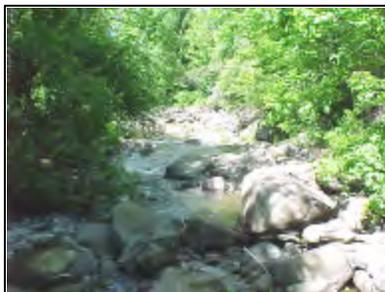
**Figure 14 Cross-section 45
Stream Type B3**

At the end of this reach, bedrock ends as the stream type transitions to B3 stream for the next 138 ft. (Fig. 14). This reach is moderately entrenched and slope decreases to 3%. The stream begins to meander back toward NYS Route 214, moving the outside bend to the right bank.

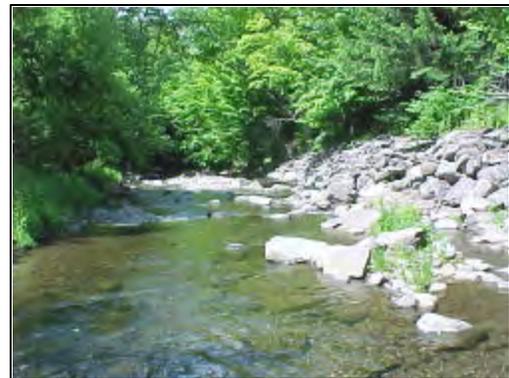
**Figure 15 Cross-section 46
Stream Type F3**

Once again the stream becomes entrenched, changing stream type to F3, for the next 109 ft. (Fig. 15). The channel slope decreases further to 1.3%. As the stream flows into the right bank, rip-rap has been installed to protect a residence (Inset G). This rip-rap wall extends 162 ft. downstream. At the end of this reach a small unnamed tributary enters the creek from the left bank. This tributary is not classified under the NYS DEC best usage classification system.

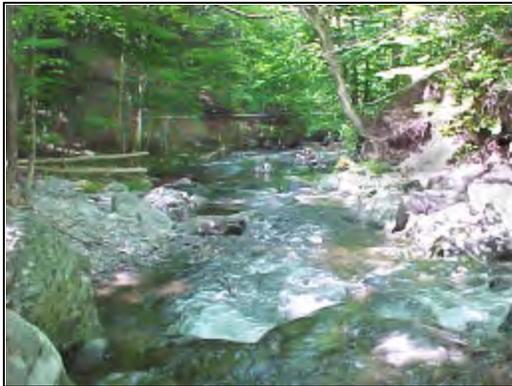
**Figure 17 Cross-section 48
Stream Type B3**

Aggradation also steepens the gradient downstream of the deposition site. This proves true for the next 209 ft. reach of B3 stream type (Fig. 17). The slope of this moderately entrenched reach increases to 3.5%.

Bank erosion monitoring site #5 is located on the right bank at the end of this reach (Inset F). The thalweg was probably up against this bank in the past, causing the right bank to undercut. The stream has now migrated away from this bank, reducing the *shear stress* and the imminent threat of erosion.

The Bank Erodibility Hazard Index (*BEHI*) score of site #5 is ranked “High”, the third highest prioritization category in terms of its vulnerability to erosion. However, this bank erosion site is considered a low priority for restoration due to its small eroding area (552 ft²), low shear stress, its lack of significant threat to infrastructure or water quality, and its trend toward self-recovery. Rubin’s (1996) stream corridor geology map indicates that the stream cuts through unconsolidated deposits in this reach (See Section 2.4, Geology of the Stony Clove Creek, for a description of these deposits).

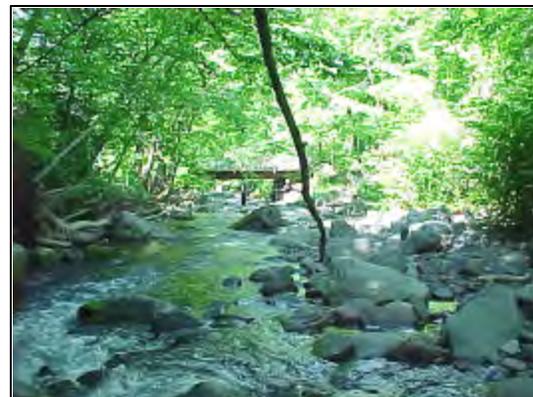
**Figure 18 Cross-section 50
Stream Type B3c**

As the stream continues, it transitions into a small 84 ft. reach of B3c stream type, due a slope decreases to 1.7%. Immediately downstream channel slope increases again to 5.4%, as the stream type changes to B3a for the next 100 ft (Fig. 18).

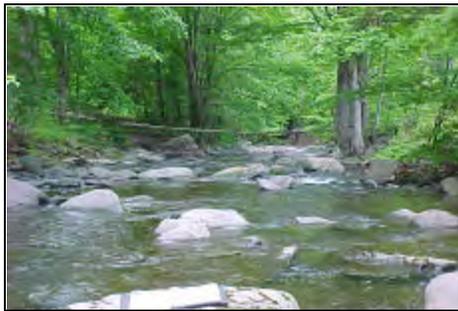
**Figure 20 Cross-section 52
Stream Type B3**

Downstream of this bridge, stream type transitions into B3 for the next 530 ft. (Fig. 20). This stream reach is moderately entrenched with a 3.1% slope.

An ephemeral tributary runs along the downstream right bridge abutment. This tributary carries turbid stormwater, possibly caused by the gravel mining operation across NYS Route 214. The source of turbidity should be confirmed through further assessment, and mitigation practices promoted.

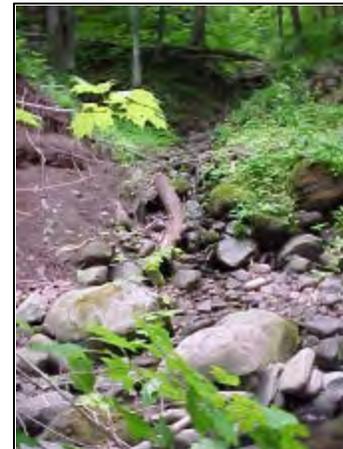
Figure 25 Tributary

The slope of this reach increases slightly to 3.6%. Bank erosion monitoring site #6 is located on the left outside meander bend of this reach (Inset E). This eroding bank measures 64 ft. in length. Although the face of the bank is bare soil, the top of the bank is well vegetated with trees and shrubs. A small unnamed tributary runs down the face of this bare bank, possibly contributing to the erosion (Fig. 25). Ongoing monitoring of this site should include an evaluation of the upland drainage issue.

The BEHI score of site #6 is ranked “High”, the third highest prioritization category in terms of its vulnerability to erosion. However, this bank erosion site is considered a low priority for restoration due to its small eroding area (687 ft²) and its lack of significant threat to infrastructure or water quality. According to Rubin’s 1996 stream corridor geology map, the stream throughout most of this reach is cut through unconsolidated deposits.

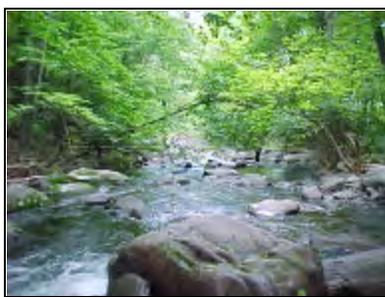
**Figure 26 Cross-section 58
Stream Type B3**

As the stream flows out of this meander bend, it becomes moderately entrenched, transitioning into a B3 stream type (Fig. 26). This 332 ft. stable reach has a slope of 3.1%.

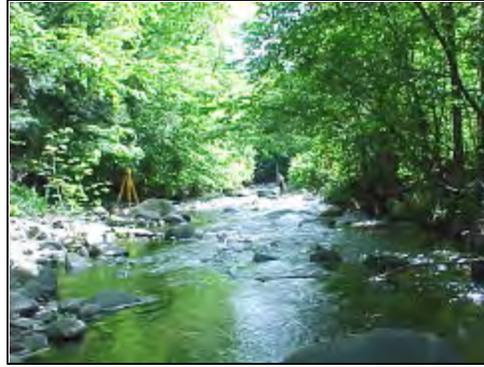
**Figure 28 Cross-section 62
Stream Type B3**

Downstream of this eroding bank, slope increase to 2.8%, as stream type changes back to B3 (Fig. 28). This 287 ft. reach is moderately entrenched.

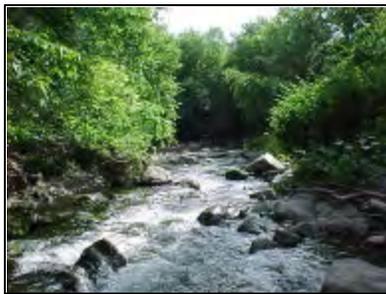
**Figure 29 Cross-section 63
Stream Type C3b**

As the stream reconnects with its floodplain, stream type changes into C3b (Fig. 29). Along this short 37 ft. reach, slope increases to 4.5%.

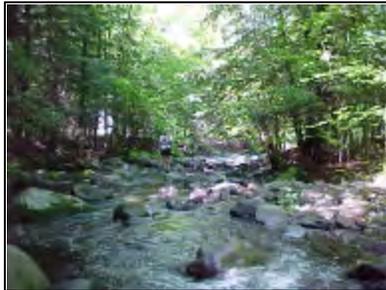
**Figure 31 Cross-section 65
Stream Type B3**

At the end of this reach, the stream channel narrows, steepens to 3.3% and becomes moderately entrenched (Fig. 31). The stream type has changed into B3 for the remaining 122 ft. of this management unit.

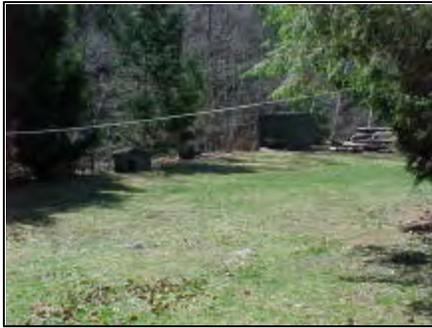
Figure 37 Planting Site #10

Planting site #10 is located at a residence (fire#2476) on NYS Route 214 (Fig. 38). There is currently a grass lawn area with scattered trees and some Japanese Knotweed on the steep stream bank, which is armored with rip-rap.

Joint planting is recommended at this site to strengthen and increase the longevity of this rip-rap, while adding aesthetic and habitat value. Increasing the buffer at least 10 to 20 ft. could increase the buffer functionality and improve stream bank stability while still allowing a significant lawn area. It is also

recommended to remove the Japanese Knotweed, which is an invasive non-native species believed to contribute to bank erosion.

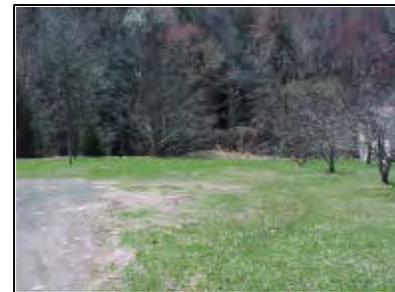
Figure 38 Planting Site #11

Planting site #11 is located at two mobile home residences (Fig. 39, fire#2456 & #2442). At this site there is a large grass lawn area, with some trees on the steep right stream bank. There is Japanese Knotweed growing on the fill area at the top of the bank.

Increasing the buffer width by at least 20 ft. is recommended to increase buffer functionality and improve stream bank stability while still allowing a significant lawn area. Japanese Knotweed should be removed from this site.

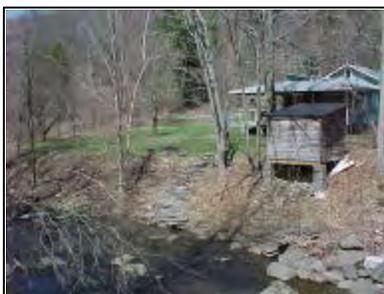
Figure 39 Planting Site #12

Planting site #12 is located at the first two residences downstream from the private bridge on the right stream bank (Fig. 40). These residences have some trees along the stream bank and grass lawn areas at the top of the bank.

At this site it is recommend that additional trees and shrubs be planted along the stream bank as well as to increase planting at the top of the bank to create a buffer. This will provide greater bank stability and habitat value for the stream.

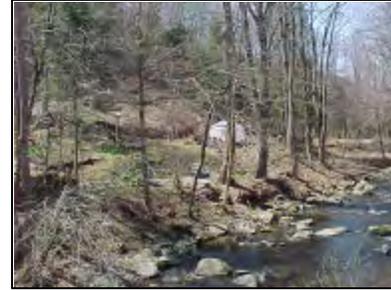
Figure 40 Planting Site #13

Planting site #13 is located at the first residence downstream from the private bridge on the left stream bank (Fig. 41). This residence has some trees along the stream bank and garden area at the top of the bank.

Plantings of native trees and shrubs along the stream bank to increase the density of vegetation on this bank, is recommended. Increasing this buffer will help prevent bank erosion and provide habitat value.

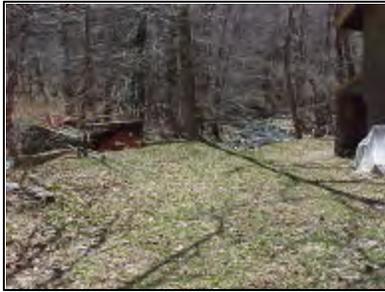
Figure 41 Planting Site #14

Planting site #14 is located at the residence (fire# 2406) along NYS Route 214 on the right stream bank (Fig. 42), at the abandoned bridge. This residence has a grass lawn area and scattered trees along the stream bank.

Recommendations include plantings of native trees and shrubs along the stream bank to increase the density of vegetation on this bank. Increasing this buffer will help prevent bank erosion and provide habitat value.

Plantings should also be implemented in the upland area.

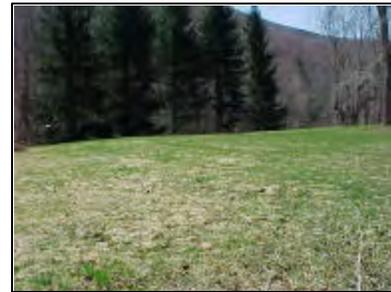
Figure 42 Planting Site #15

Planting site #15 is located at the residence (fire# 2384) along NYS Route 214 on the right stream bank (Fig. 43). This site has a large grass lawn area, which is a considerable distance away from the stream, and a well vegetated stream bank. To improve buffer functionality native trees and shrubs should be planted in this upland area.

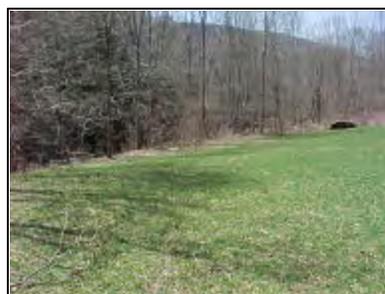
Figure 43 Planting Site #16

Planting site #16 is located at the residence (fire# 2368) along NYS Route 214 on the right stream bank (Fig. 44). This site has a large grass lawn area with trees on the steep stream bank. Increasing buffer width by at least 20 ft. will improve buffer functionality and stream bank stability while still allowing a significant lawn area.

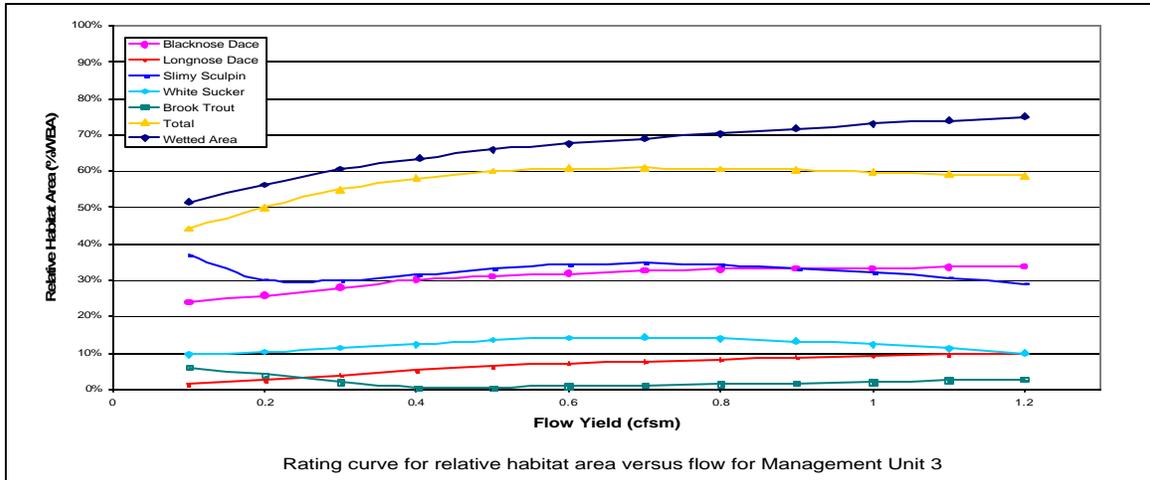
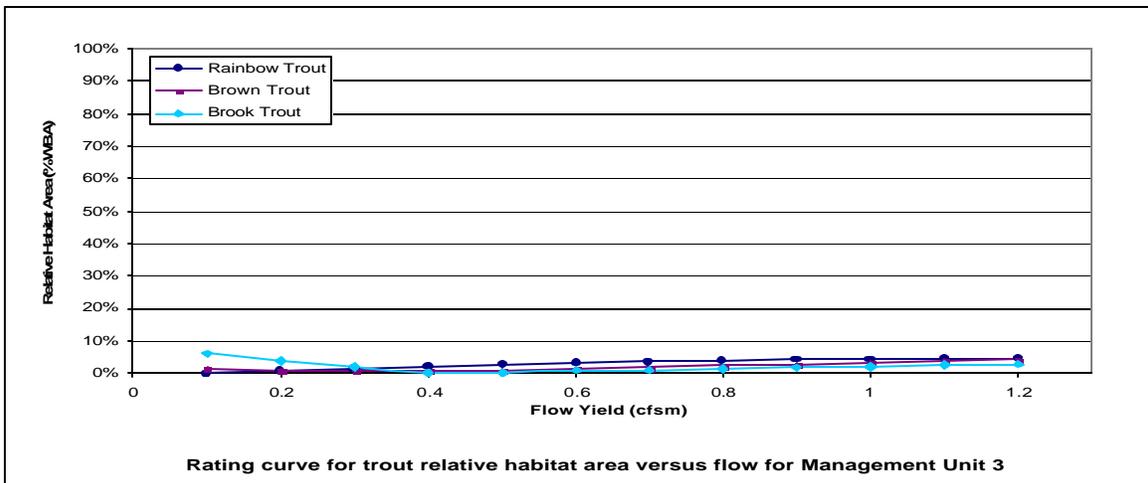
Figure 45 MesoHABSIM habitat rating curve for Management Unit 3

Management unit #3 is dominated by runs and contains several bedrock areas with boulders, large substrate, and some woody debris. It is slightly deeper and faster than management unit #2. At very low flows, *wetted area* is half the size of bankfull wetted area; this proportion increases steadily to 80% of bankfull wetted area at higher flows. At all flows, 80% of the wetted area is prime habitat. The habitat level for all species peaks between 0.5 cfs and 1.0 cfs and is relatively stable. The unit has a medium amount of habitat available for slimy sculpin and blaknose dace. The other three species from the target community have habitat levels that comprise less than 15% of the bankfull wetted area. Brown and rainbow trout have more habitat at higher flow levels.

A potential upstream migration barrier occurs at Edgewood Falls at all flows, segmenting the fish habitat. Generally good riparian conditions provide canopy cover to the unit, moderating temperatures during summer low flows.
