Management Unit 6

Greene County - Town of Hunter
Cross Section 107 to Cross Section 116

Management Unit Description

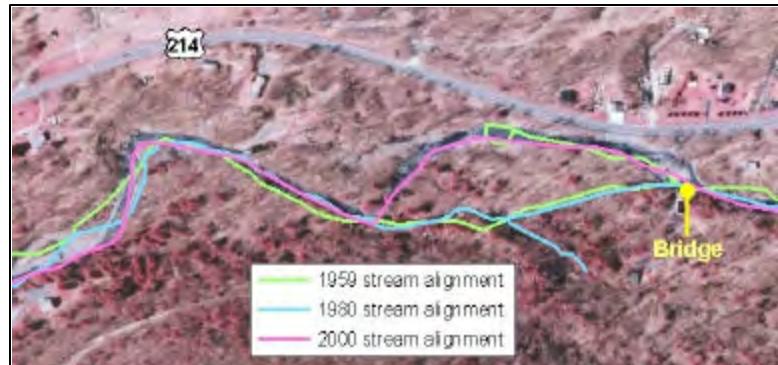
Figure 2a Historical stream channel alignments of Management Unit 6

Significant channel migration and manipulation have occurred over the last 50 years, as can be seen in the historical stream alignments. The 1959 stream alignment in Figure 2a shows the stream channel originally flowed to the left after the bridge at the end of Management Unit #5. Another stream

Some time after 1980 the main stream channel shifted to the right channel and abandoned the left

stream channel. This dramatic change probably occurred during a flood event.

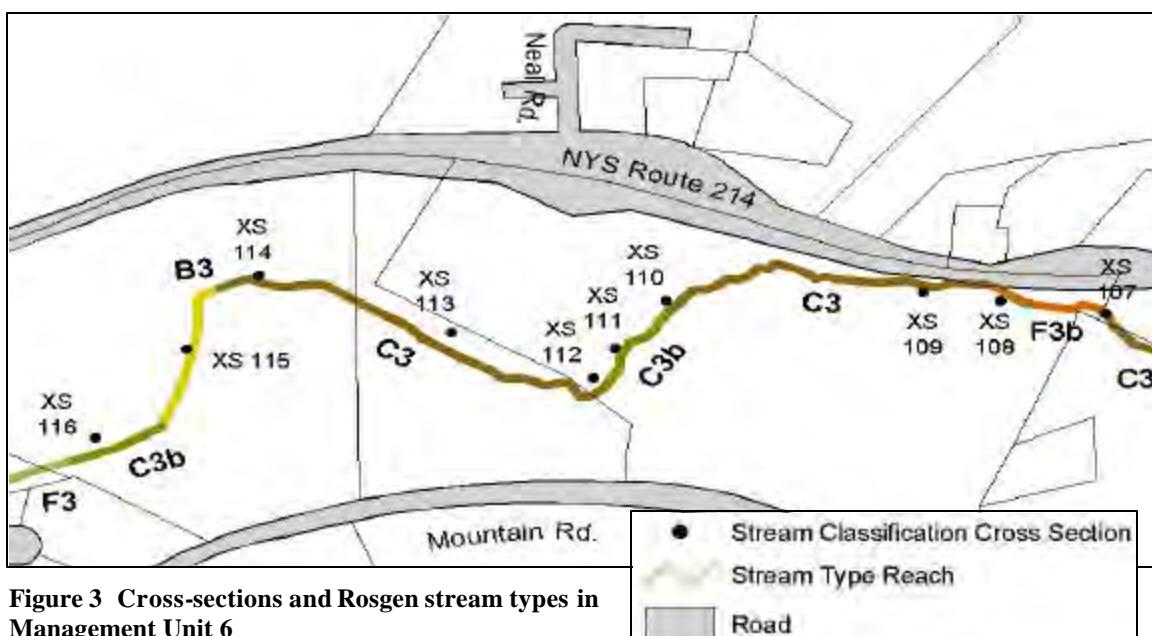
Figure 3 Cross-sections and Rosgen stream types in Management Unit 6

Stream morphology, or shape (i.e., slope, width and depth) is more consistent in this unit than in previous units (Fig. 3), with longer reaches of the same *stream type* (See Section 3.1 for stream type descriptions).

The predominant stream type in this unit is a “C” channel, which are particularly sensitive to disturbance of streamside vegetation, and sediment supply fluctuations. Historical channel migration has left areas of degraded vegetation in the floodplain which have not yet fully recovered. *Radius of curvature* at two locations is smaller than expected at this valley setting; one of the sites is exhibiting bank erosion, while the other appears stable. Bedrock at the downstream end of the management unit provides grade control.

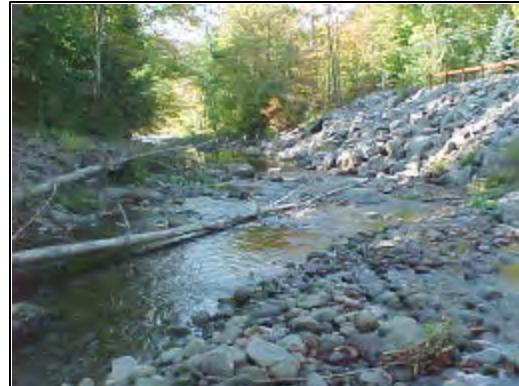
**Figure 4 Cross-section 108
Stream Type F3b**

Management unit #6 begins with a 217 ft. reach of F3b stream type (Fig. 4). The stream channel is *entrenched*, or confined within the stream banks during high flood events, which can result in *incision*. This reach is fairly steep at 3.1% slope with cobble-dominated bed material.

At the upstream end of this management unit, the stream splits into three channels as it must pass a road crossing (Inset H). The majority of the stream passes through the culvert bridge on the right side of the stream at low flows. The remaining stream flow flows straight and falls into two smaller culverts which pass under the road crossing just above the stream grade level. Higher flows spill directly across the roadway, rendering it impassable and requiring significant maintenance after flood flows ebb.

This overflow also occurs during smaller rain events, when debris clogs the two smaller culverts. This road crossing causes channel instability downstream by dividing channel forming flows and creating a barrier to sediment transport.

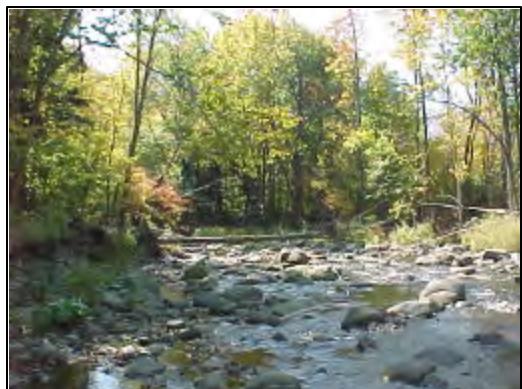
**Figure 7 Cross-section 110
Stream Type C3**

As the rip-rap comes to an end, the channel reconnects with its floodplain. This reduces the threat of erosion because flood flows are able to spread out over a floodplain instead of remaining contained within the stream banks. Slope decreases to 1.7% during this 688 ft. reach of C3 stream (Fig. 7).

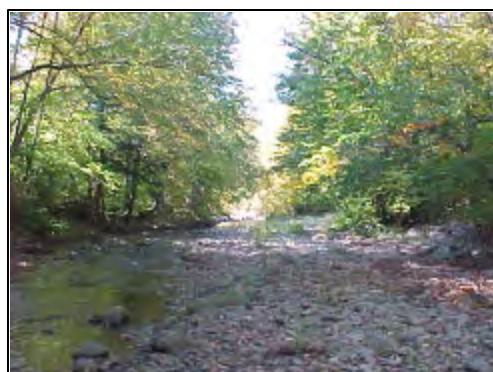
**Figure 8 Cross-section 113
Stream Type C3**

At the end of this reach the stream turns sharply to the right and slope decreases to 1.6%, as stream type transitions back to C3 for the next 848 ft. reach (Fig. 8).

As the stream straightens, the channel widens. The *thalweg* is located directly against the left bank. The right side of the channel is aggrading and does not pass water during low flow. Although no NYS DEC stream disturbance permits are on record for this area, the channel shape and evidence of *sidecast* stream bed material indicate this channel was probably reshaped by excavating equipment. Riparian vegetation is fairly healthy young forest providing good overhead cover.

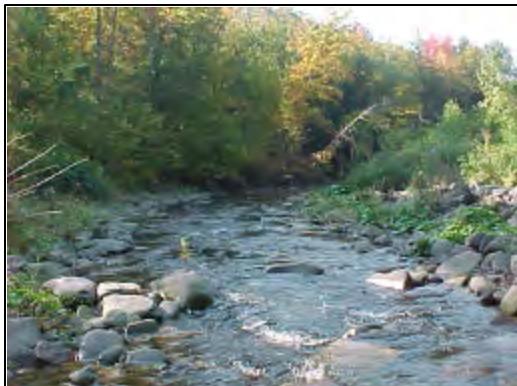
**Figure 13 Cross-section 115
Stream Type B3**

Emerging from the debris jam, the channel bends to the left and splits for a short length around a central bar. The channel becomes moderately entrenched and slope increases to 1.9%, transitioning into a B3 stream type for the next 360 ft (Fig. 13).

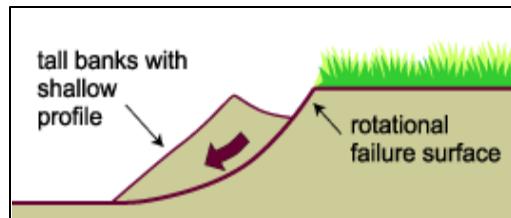
Figure 12 Rotational failure (USDA, 2003)

The high bank with shallow slope angles and exposed silts/clays is indicative of a common form of bank failure associated with the glacial lake deposits known as *rotational failure*. A 680 ft. *rotational failure* has occurred above the failing bank (Fig. 11). A rotational failure is typically a deep-seated failure which occurs in cohesive materials when a block of disturbed, bank material slides along a curved failure surface (fault). The block tends to rotate (appears to "slump") back toward the bank as it slides, in a rotational slip (Fig. 12) (USDA, 2003).

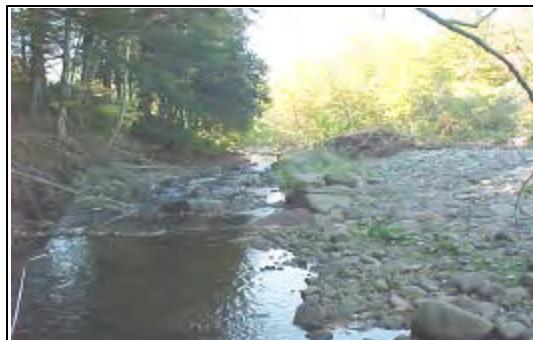
**Figure 14 Cross-section 116
Stream Type C3b**

As the stream reconnects with its floodplain, stream type changes to C3b for the final 143 ft. of this management unit (Fig. 14). The slope steepens to 2.4%. Bedrock armors the left bank and channel invert, setting the grade here, while a large gravel bar has formed on the right bank. Gravel is often deposited on the inside meander of a stream where flow velocities are slower.

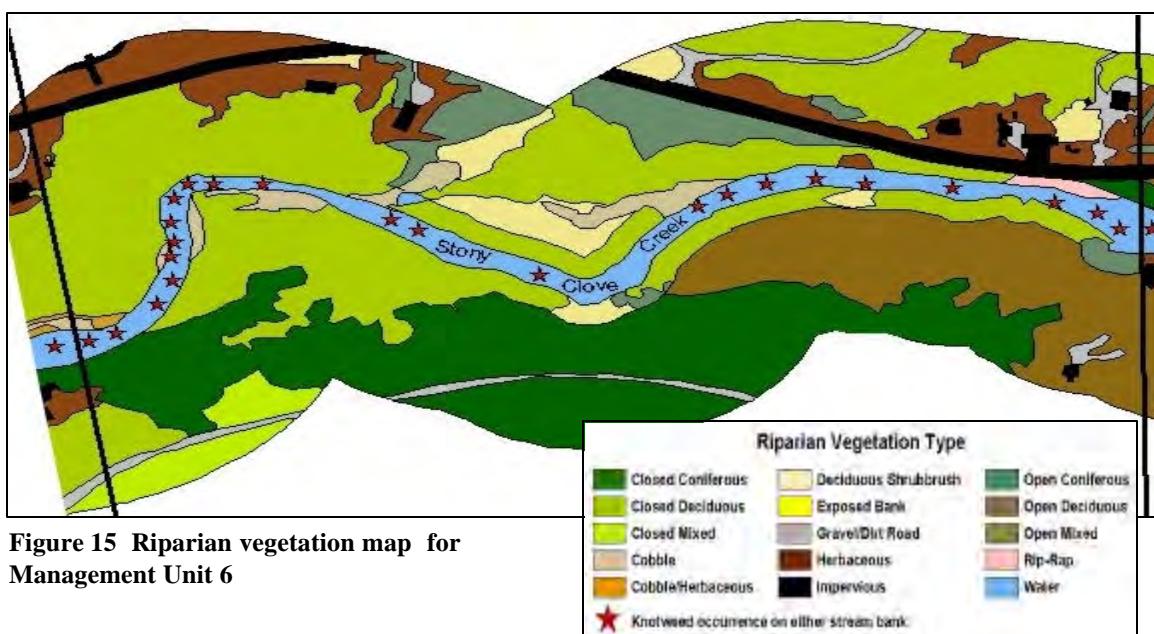
Figure 15 Riparian vegetation map for Management Unit 6

An analysis of vegetation was conducted using aerial photography from 2001 and field inventories (Fig. 15 & Appendix A). Japanese knotweed occurrences were documented as part of the MesoHABSIM aquatic habitat inventory conducted during the summer of 2002 (Appendix B).

The predominant vegetation type within the 300 ft. riparian buffer is forested (79%) followed by herbaceous (8%). Areas of herbaceous (non-woody) cover provide opportunities to improve the riparian buffer with more flood-resistant species. *Impervious* area (4%) within this unit's buffer is primarily the NYS Route 214 roadway and private residences.

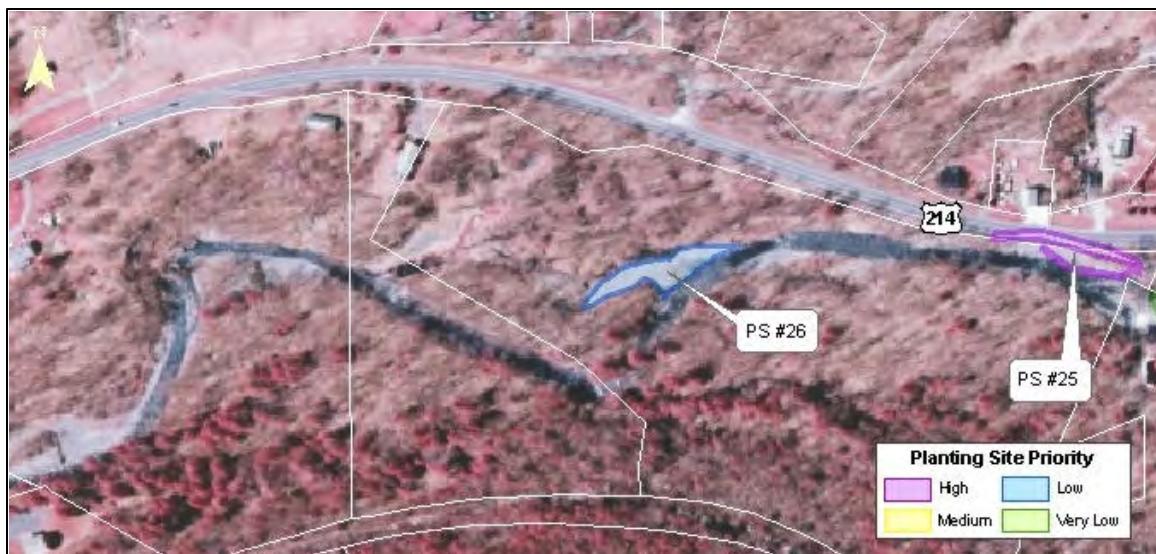
Figure 16 Planting sites location map for Management Unit 6

In June 2003, suitable riparian improvement planting sites were identified through a watershed-wide field evaluation of current riparian buffer conditions and existing stream channel morphology (Fig. 16). These locations indicate where plantings of trees and shrubs on and near stream banks can help reduce the threat of serious bank erosion, and can help improve aquatic habitat as well. In some cases, eligible locations include stream banks where rock rip-rap has already been placed, but where additional plantings could significantly improve stream channel stability in the long-term, as well as biological integrity of the stream and floodplain. Areas with serious erosion problems where the stream channel requires extensive reconstruction to restore long-term stability have been eliminated from this effort. In most cases, these sites can not be effectively treated with riparian enhancement alone, and full restoration efforts would include re-vegetation components. Two appropriate planting sites were documented within this management unit.

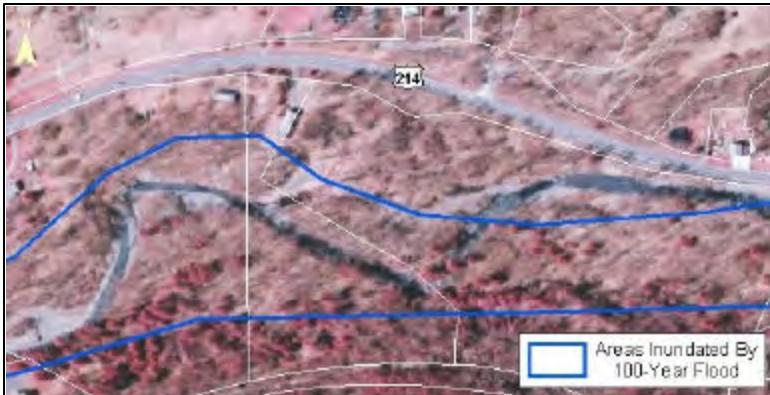
Figure 20 100-year floodplain boundary in Management Unit 6

According to the NFIP maps, there are no houses located within the 100-year flood boundary in this management unit (Fig. 20). The current NFIP maps are available for review at the Greene and Ulster County Soil & Water Conservation District offices.

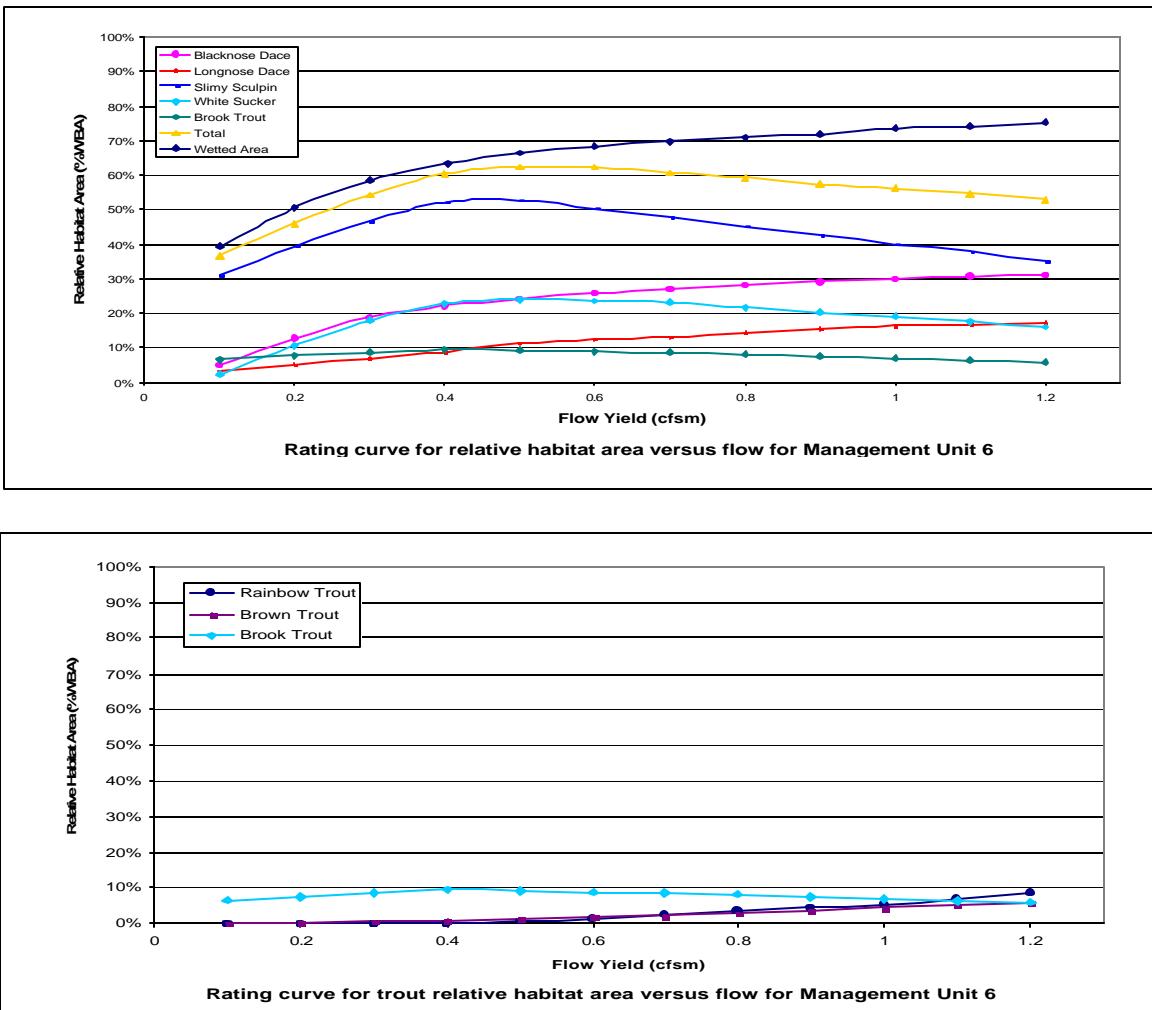
Figure 22 MesHABSIM habitat rating curves for Management Unit 6

The upper portion of management unit #6 runs very close to the road, but then veers away in the lower half. The unit consists mostly of fast-flowing, shallow habitats (riffles and rapids) with boulders, shading, and woody debris. The wetted area increases from 40% to 80% of bankfull wetted area with an inflection point near 0.5 cfsm. The majority of wetted area is highly suitable for the target community. The overall suitable habitat level increases strongly before flows reach 0.7 cfsm and then gradually declines. For the majority of species, the habitat increases appreciably between flows of 0.2 and 0.4 cfsm, though white sucker and slimy sculpin habitat has a peak a little after 0.45 cfsm. Brook trout habitat stays relatively constant at a 10% level. Brown and rainbow trout habitat increases significantly at higher flows. Habitat could be improved in this reach through the vegetative treatments recommended above at erosion sites #14 and 15. (See general recommendations for aquatic habitat improvement in Section 6.6)
