Management Unit 18

Ulster County - Town of Shandaken
Between Cross Section 172 & 173 to Chichester Bridge

Management Unit Description

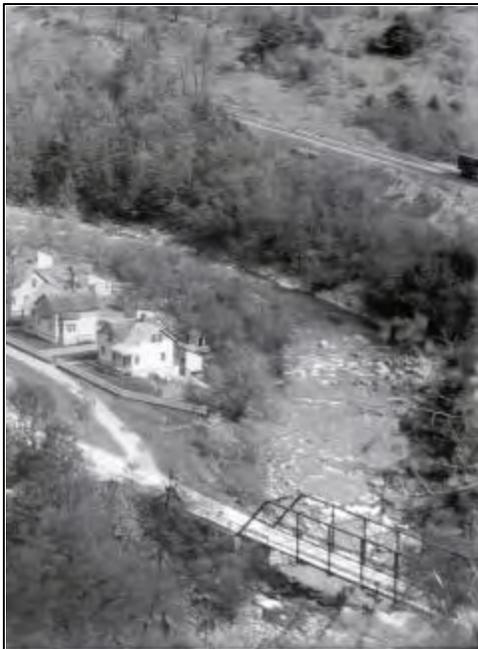
Figure 3 Looking upstream over the NYS Route 214 bridge at Chichester
Courtesy of the Gale Collection

While these glacial soils are susceptible to erosion on steep streambanks, they nonetheless will recover their vegetation (Fig. 3).

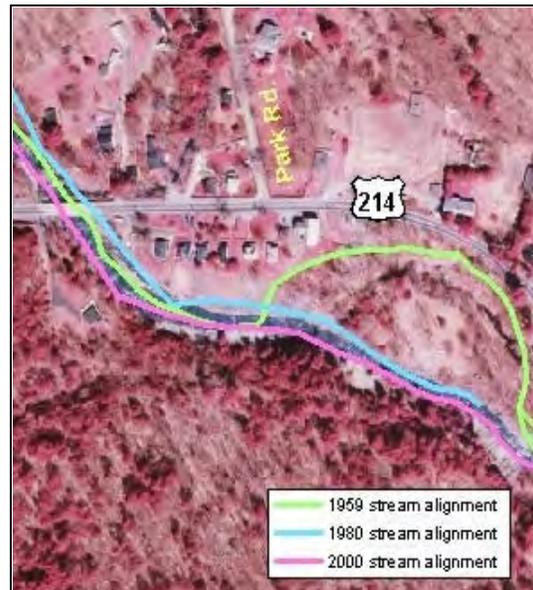
Figure 4 Historic stream channel alignments in Management Unit 18

As seen from the historical stream alignments, the channel alignment has changed significantly over the years (Fig. 4).

After the 1987 flood event, an emergency permit was issued to John Macko to repair log cribbing (Inset F) and rip-rap (Inset E) along his stream bank. In 1996, another permit was issued to John Macko to repair the log cribbing using gravel taken from the stream as backfill and to retrieve rip-rap washed into the stream during the flood. In 1996, DeSilva, Rainer, Biewald, et al. was issued an emergency permit to re-channel the stream through a gravel deposit, skimming gravel for use as backfill, and to stockpile large rocks for rip-rap (Inset C).

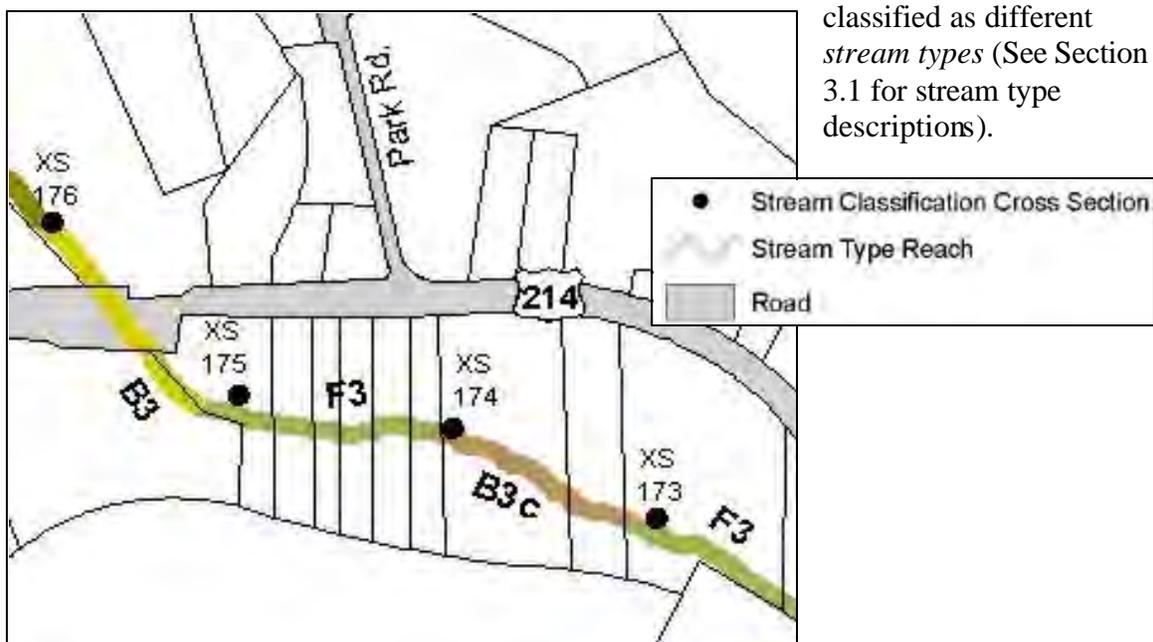
Figure 5 Cross-sections and Rosgen stream types in Management Unit 18

Stream morphology, or shape (i.e., slope, width and depth) changes several times in this unit (Fig. 5), creating small reaches with differing morphologic characteristics, which are classified as different *stream types* (See Section 3.1 for stream type descriptions).

Entrenchment in this management unit is controlled in the upstream reaches by a high valley wall above the left bank. As the channel departs from the toe of the steep valley wall, entrenchment moderates, and bar development is apparent. Widespread revetment installations have limited the belt width of the meandering downstream reaches.

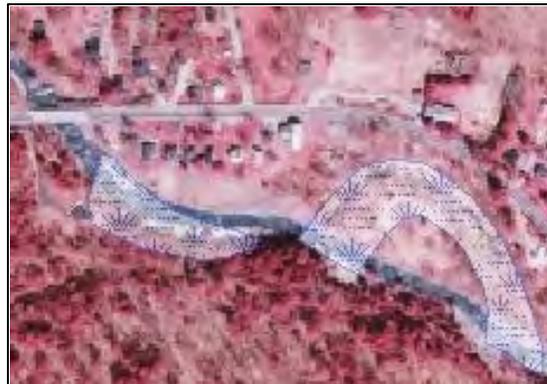
Figure 7 Federally Designated Wetlands

There are two federally designated wetlands within this management unit (Fig. 7). The larger wetland, which is 2.5 acres in size, is classified as palustrine scrub-shrub, broad-leaf deciduous, and temporarily flooded (PSS1A). The smaller wetland, which is 1.2 acres in size, is riverine upper perennial, with an unconsolidated shore, and is seasonally flooded (R3USC).

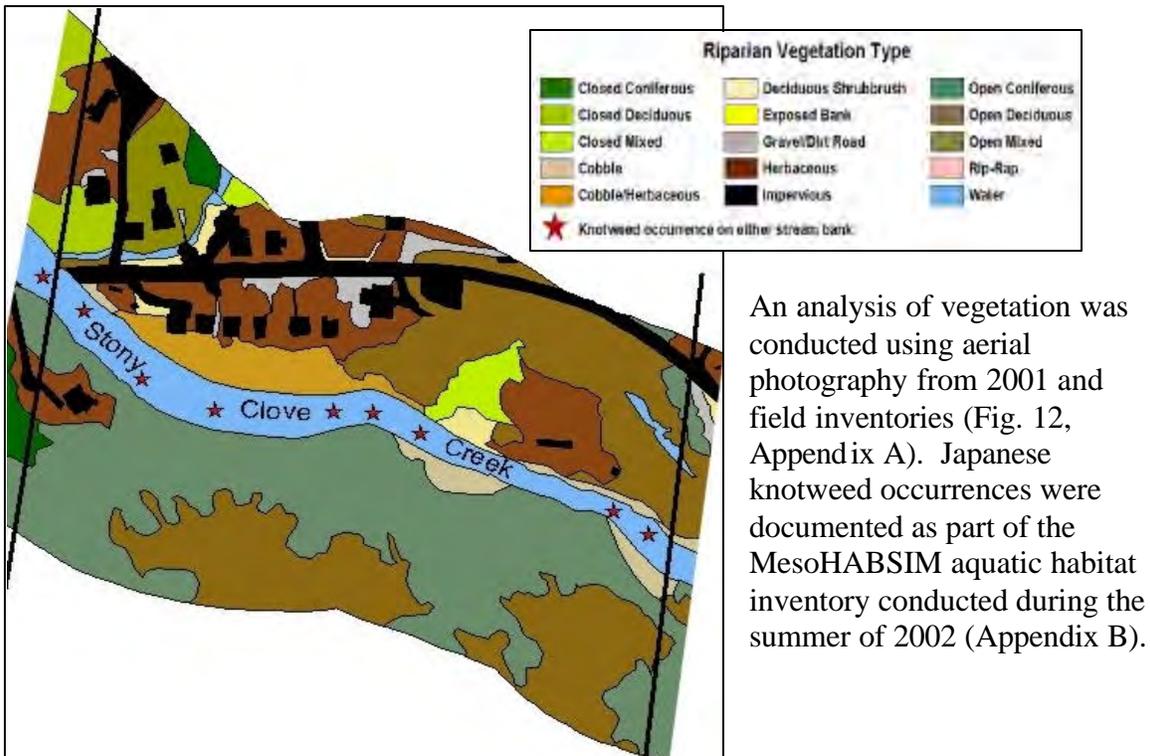
Figure 12 Riparian vegetation map of Management Unit 18

An analysis of vegetation was conducted using aerial photography from 2001 and field inventories (Fig. 12, Appendix A). Japanese knotweed occurrences were documented as part of the MesoHABSIM aquatic habitat inventory conducted during the summer of 2002 (Appendix B).

The predominant vegetation type within the 300 ft. riparian buffer is forested (67%) followed by herbaceous (13%). Areas of herbaceous (non-woody) cover present opportunities to improve the riparian buffer with plantings of more flood-resistant species. *Impervious* area (9%) within this unit's buffer is primarily the NYS Route 214 along with private residences.

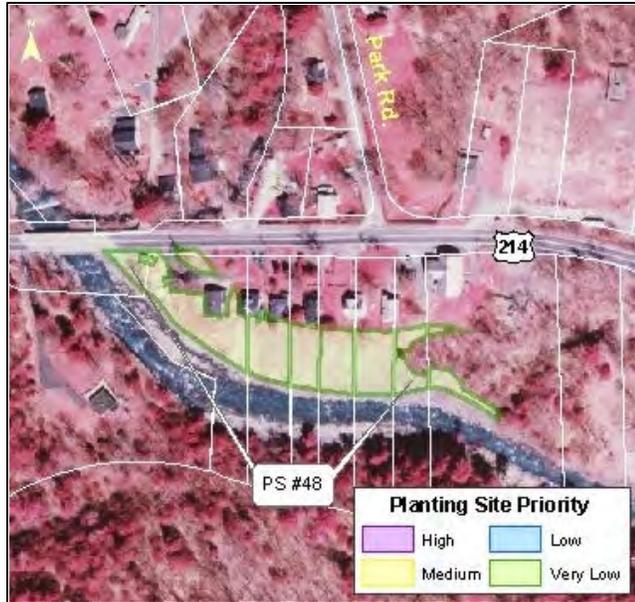
Figure 13 Planting sites location map for Management Unit 18

In June 2003, suitable riparian improvement planting sites were identified through a watershed-wide field evaluation of current riparian buffer conditions and existing stream channel morphology (Fig. 13). These locations indicate where plantings of trees and shrubs on and near stream banks can help reduce the threat of serious bank erosion, and can help improve aquatic habitat as well. In some cases, eligible locations include stream banks where rock rip-rap has already been placed, but where additional plantings could significantly improve stream channel stability in the long-term, as well as biological integrity of the stream and floodplain. Areas with serious erosion problems where the stream channel requires extensive reconstruction to restore long-term stability have been eliminated from this effort. In most cases, these sites can not be effectively treated with riparian enhancement alone, and full restoration efforts would include re-vegetation components. One appropriate planting site was documented within this management unit.

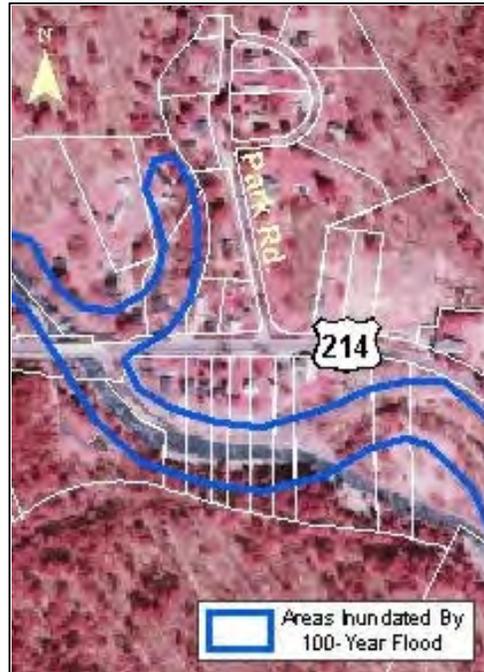
Figure 15 100-year floodplain boundary in Management Unit 18

According to NFIP maps, there are two houses located within the 100-year floodplain boundary in this management unit (Fig. 15). The current NFIP maps are available for review at the Greene and Ulster County Soil & Water Conservation District offices.

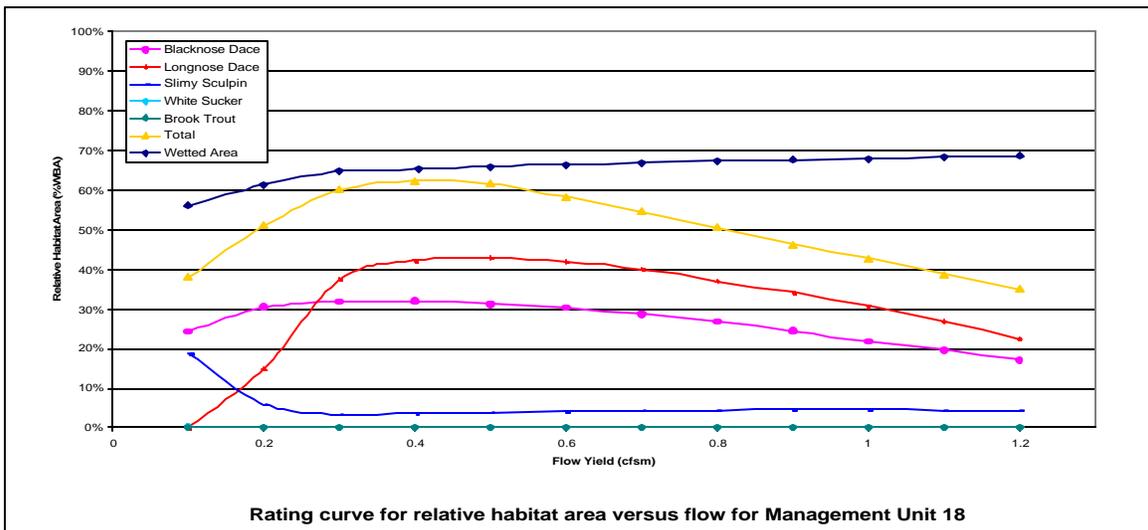
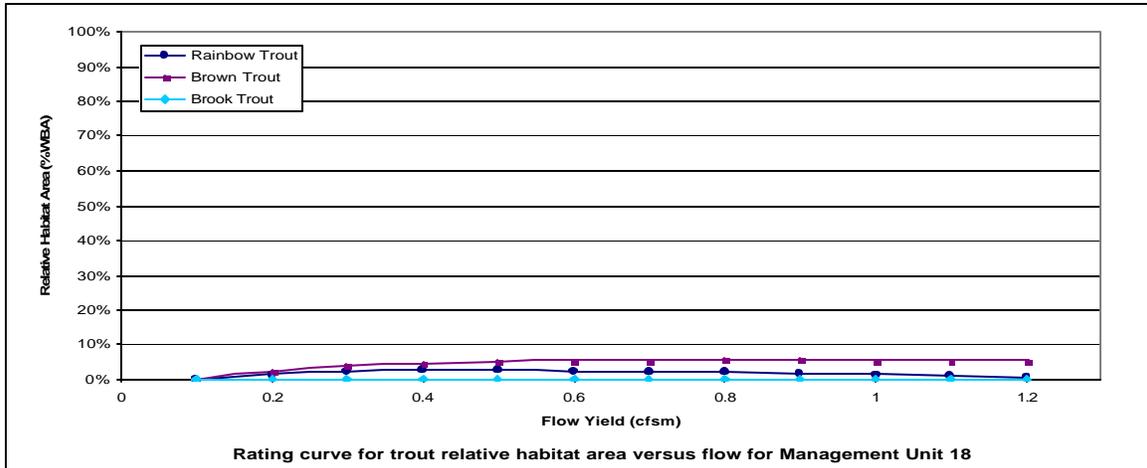
Figure 16 MesoHABSIM habitat rating curves for Management Unit 18

Management unit #18 has many boulders and some shallow margins. With the exception of the furthest upstream reach, it is somewhat shallower, but faster, than management unit #17. *Wetted area* covers only 55%-70% of the bankfull wetted area through the investigated range of flows, with an inflection point near 0.3 cfs. This unit is comprised primarily of rapids and runs that turn into riffles and rapids at higher flows. The overall habitat increases with total wetted area until around 0.3 cfs, beyond which, habitat steadily declines (Fig. 16). The highest habitat levels in this unit are for longnose dace, followed by blacknose dace. All other species have sparse suitable habitat. Consistent with the results from most other management units, adult brown and rainbow trout have limited amounts of low-quality habitat available. (See general recommendations for aquatic habitat improvement in Section 6.6)
