Management Unit 21
 Ulster County - Town of Shandaken
 Cross Section 189 to confluence with Esopus Creek

Management Unit Description

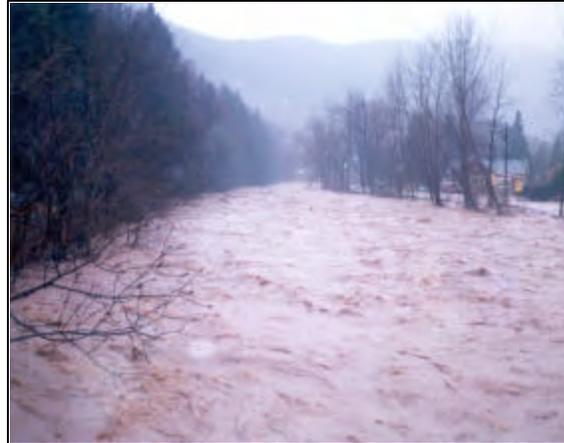
Figure 2 Flood of 1980, along NYS Route 214 in Phoenicia Courtesy of the Gale Collection

In the time since the most recent glacial retreat, the Stony Clove Creek has seen over a hundred “100-yr” floods, and perhaps ten “1000-yr” floods (Fig. 2). These very large floods would have eroded tremendous volumes of soil and rock from the surrounding mountainsides, which then would have been deposited at the mouth of the creek, creating the flats on which the Village of Phoenicia is built (Fig. 3).

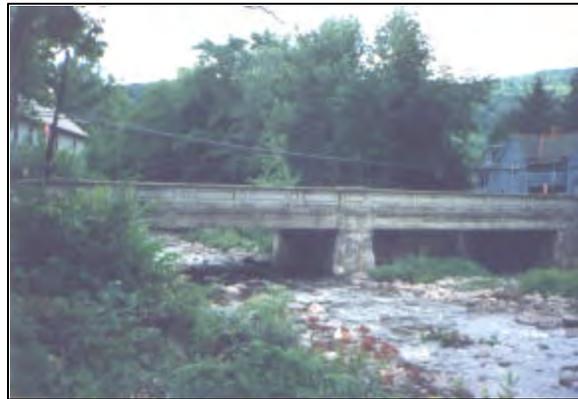
Figure 6 Old Phoenicia Bridge

In 1992, the NYS Department of Transportation (DOT) was issued a permit to upgrade the Phoenicia Bridge with a pile foundation and clear-span superstructure, eliminating the center pier used in the former bridge (Fig. 6). Heavy stone fill was used for abutment scour protection. Approximately 20 ft. of a failed stone retaining wall was also replaced.

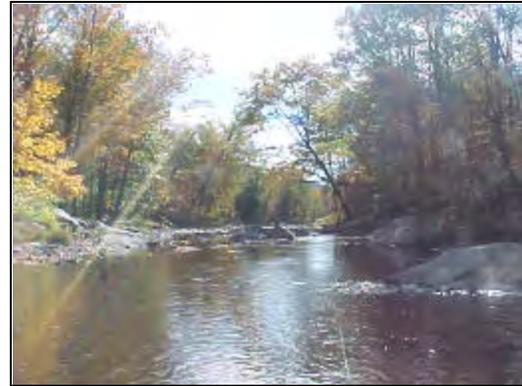
**Figure 11 Cross-section 194
Stream Type B4c**

As channel slope decreases, stream type changes back to B3c for the next 904 ft. (Fig. 11). The upstream portion of this reach has a wide channel with an extremely flat slope of 0.4%, while the lower portion of the reach narrows and steepens to 1.7%. Dominant channel material becomes considerably finer, but remains cobble. Downstream of where the stacked rock wall (Inset H) along the left bank ends, rip-rap (Inset C) has been installed on the bank.

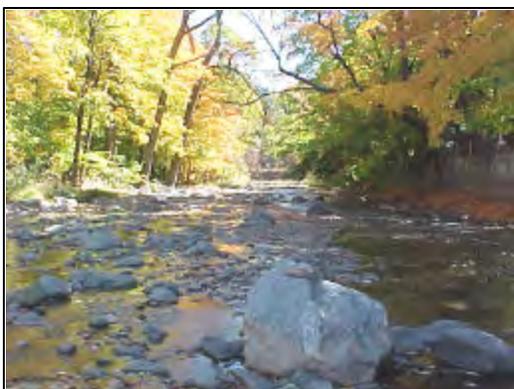
Figure 16 Cross-section 199 Stream Type C3

As the stream approaches the Phoenicia Bridge, the channel begins to narrow and reconnect with its floodplain. Stream type transitions to C3 for the last 979 ft. of this management unit (Fig. 16). Dominant bed material remains cobble and the channel slope increases slightly to 1.2%.

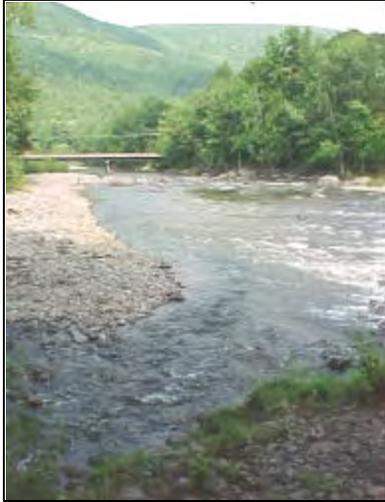
Figure 20 Confluence with Esopus Creek

Proceeding downstream, the Stony Clove Creek confluences with the Esopus Creek, which flows another 8 miles before entering the Ashokan Reservoir (Fig. 20). The Ashokan Reservoir supplies approximately 10% of NYC's drinking water.

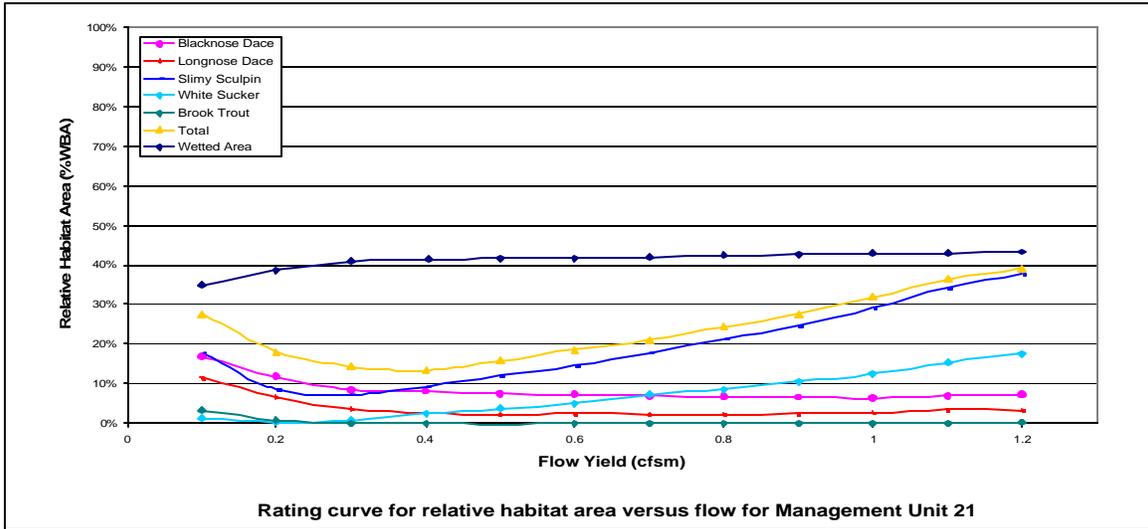
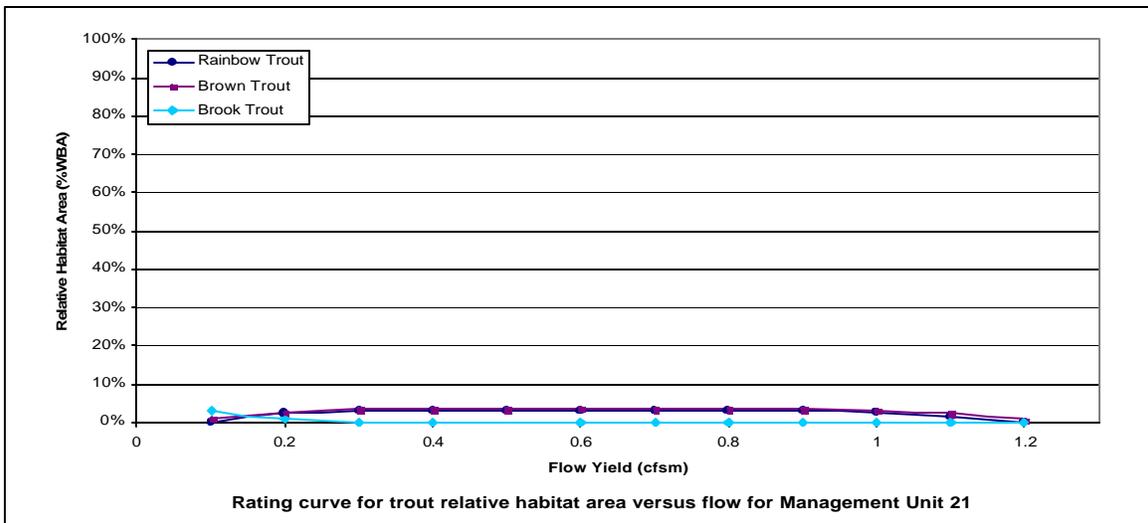
Figure 30 MesoHABSIM habitat rating curves for Management Unit 21

Management unit #21 has some boulder cover and abundant shallow margins, but very little shading and overhanging vegetation (Fig. 30). The substrate is variable. Average hydraulic conditions are similar to those of management unit #20, but exhibit a slightly wider range of velocities. *Wetted area* covers less than half of the bankfull wetted area and stays relatively constant. The *hydro-morphological units* (HMUs) become much larger above 1.0 cfs but are still highly variable. The community habitat rating curve shows a trend that is unlike anywhere else in the system. This is attributed to the curve being dominated by slimy sculpin. Similar to management unit #20, sculpin have their lowest habitat levels at around 0.3 cfs. White sucker also contribute to the unique trend by having more habitat available at higher flows. As flow increases, blacknose dace habitat declines and longnose dace have little suitable habitat. While the introduced trout

species have small amounts of excellent habitat, no suitable brook trout habitat whatsoever is available in this management unit.

Overwide, aggradational conditions lead to potential thermal impairment and filling of pools in the unit. Planting recommendations for the unit will mitigate these habitat deficiencies. (See Section 6.6 general recommendations for aquatic habitat improvement)
