3.3 Watershed Assessment and Inventory

A watershed assessment protocol was prepared to support the development of the Schoharie and East Kill Stream Management Plans. The protocol was meant to provide the project team with a general baseline inventory of conditions throughout the stream corridor.

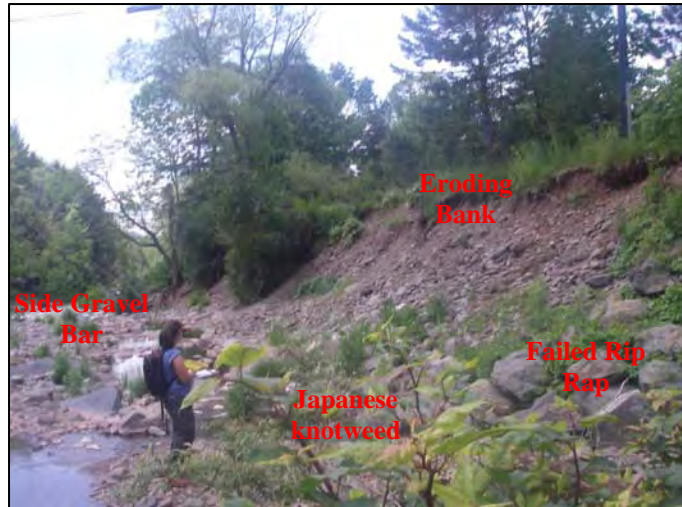
Schoharie/East Kill Project Team Member assesses a stretch of Schoharie Creek as part of 2006 walkover.

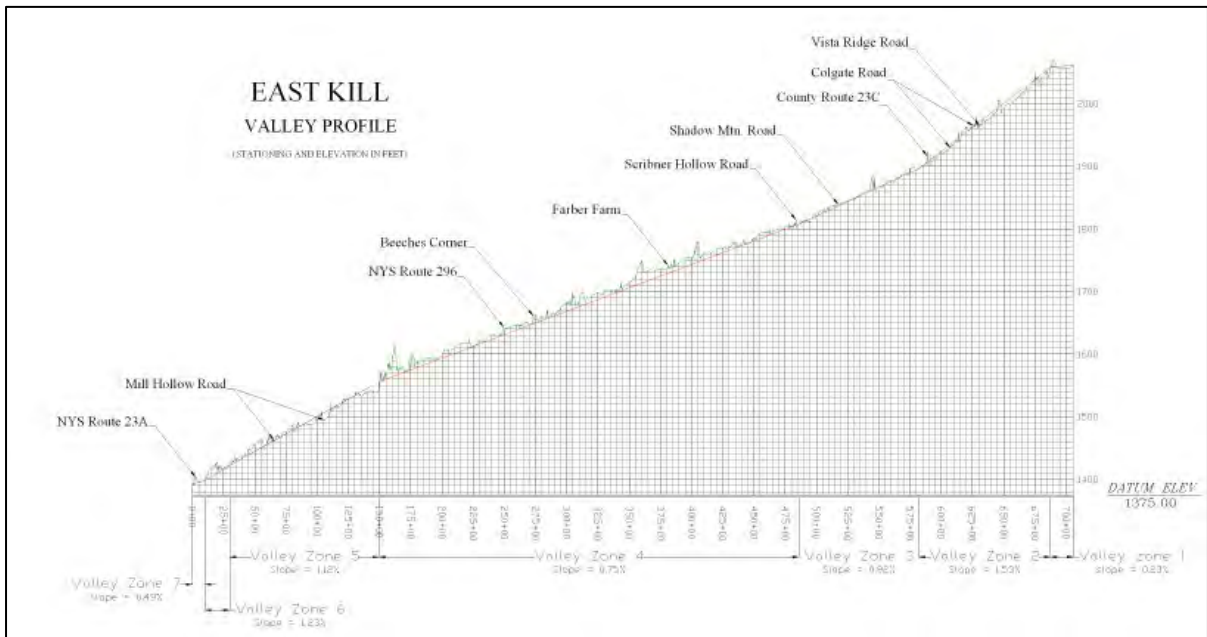
Figure 3.3.1 East Kill Valley Profile

1) Valley Slope - A profile of the valley slope was created using United States Geologic Survey contour data. This profile was divided into segments based on common slope characteristics (Figure 3.3.1).
