3.3 Watershed Assessment and Inventory

A watershed assessment protocol was prepared to support the development of the Manor Kill Stream Management Plan. The protocol was meant to provide the project team with a general baseline inventory of conditions throughout the stream corridor.

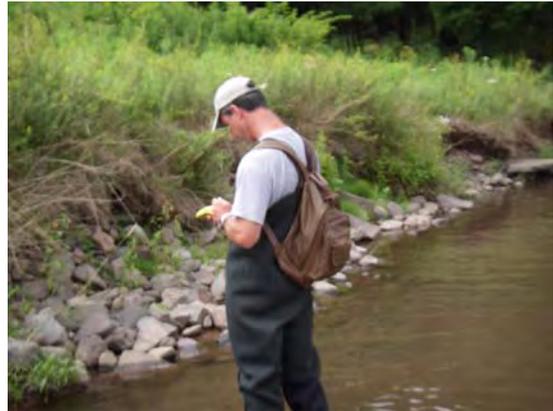
Schoharie County SWCD staff collecting data on an eroding bank in the Manor Kill, 2008.

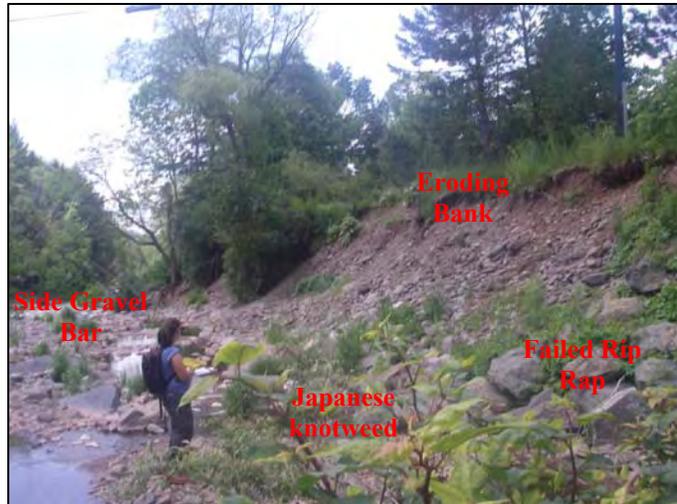
GCSWCD personnel assess a stretch of Schoharie Creek that includes many stream features examples.
