5.2 Infrastructure Recommendations

Table 1 List of infrastructure points of concern associated with the Rondout Creek and select tributaries

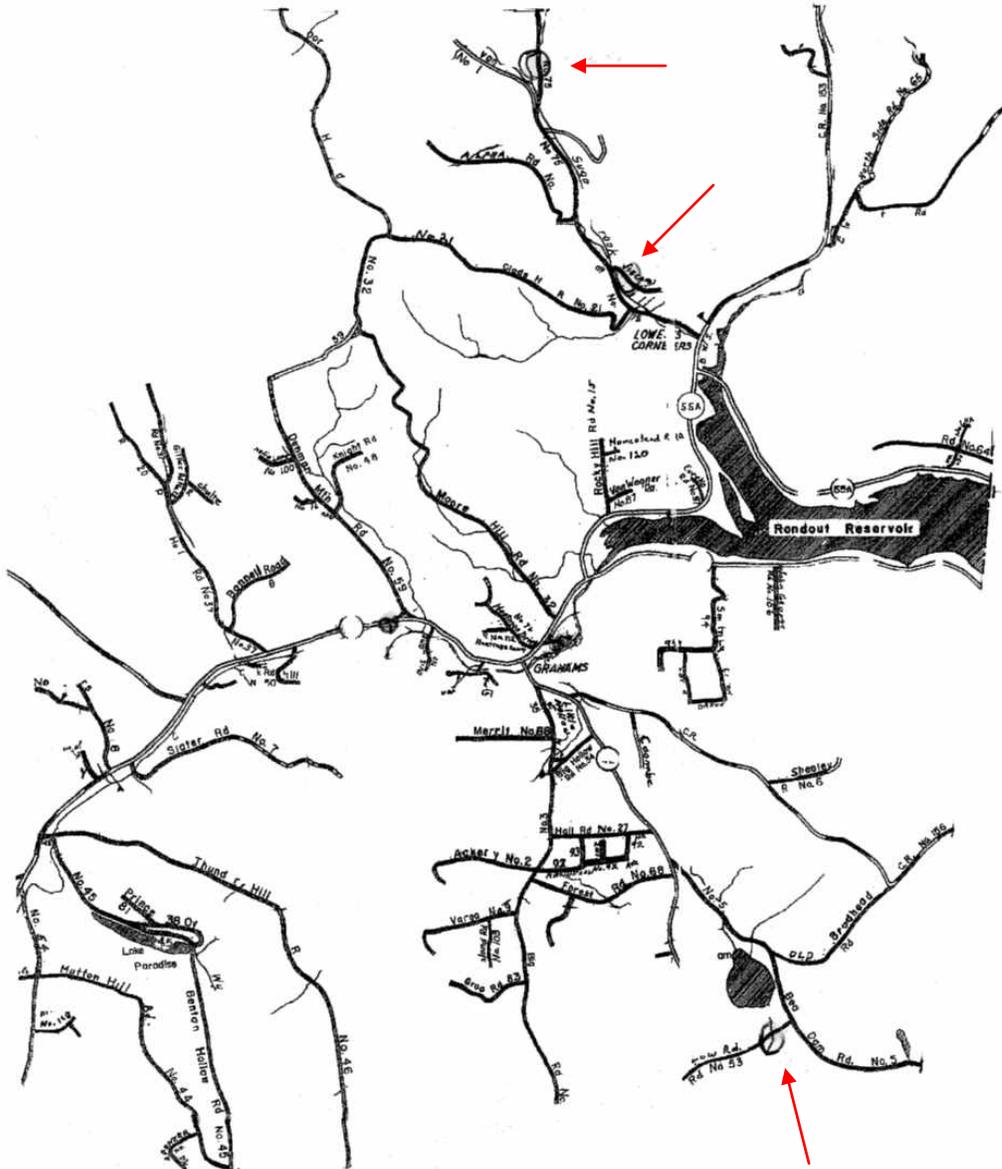
Figure 1 Map indicating points of concern for the Town of Neversink Highway Department

George Rd.			
<i>Town of Neversink Highway Department²</i>			
1. Low Road ³	Culvert Pipe #20 is too small; Stream jumps its bank during high flow and flows down road almost every rainfall; Pipe has been repaired several times.	Replace with larger ellipse pipe.
