3.3 Watershed Assessment and Inventory

A watershed assessment protocol was prepared to support the development of the Schoharie and East Kill Stream Management Plans. The protocol was meant to provide the project team with a general baseline inventory of conditions throughout the stream corridor.

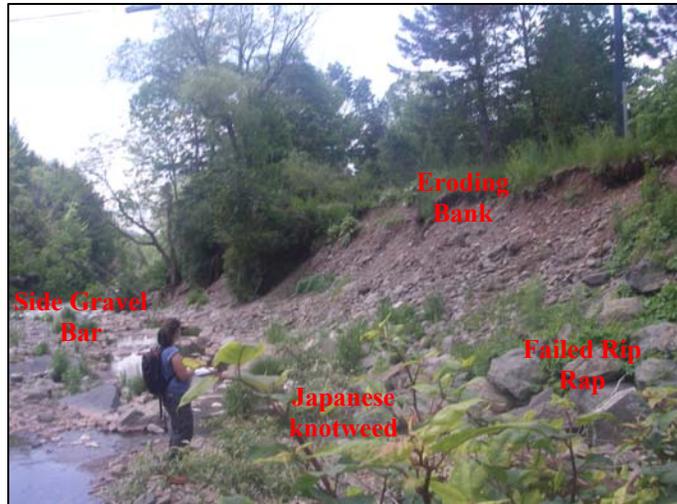
Schoharie Project Team Member assesses a stretch of Schoharie Creek as part of 2006 walkover.

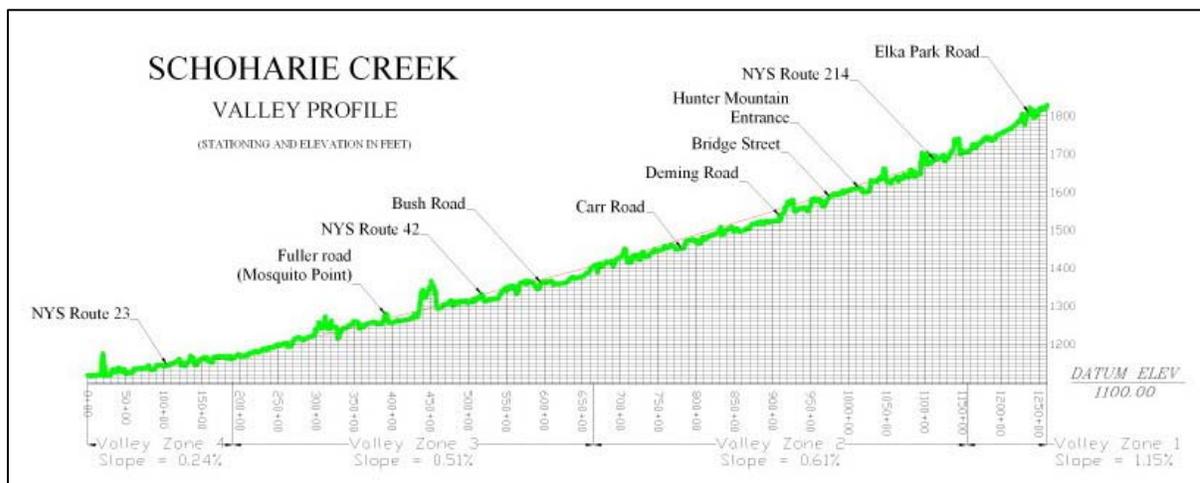
1) Valley Slope - A profile of the valley slope was created using United States Geologic Survey contour data. This profile was divided into segments based on common slope characteristics (Figure 3.3.1).

Figure 3.3.1 Schoharie Creek Valley Profile
