IV-K: Infrastructure

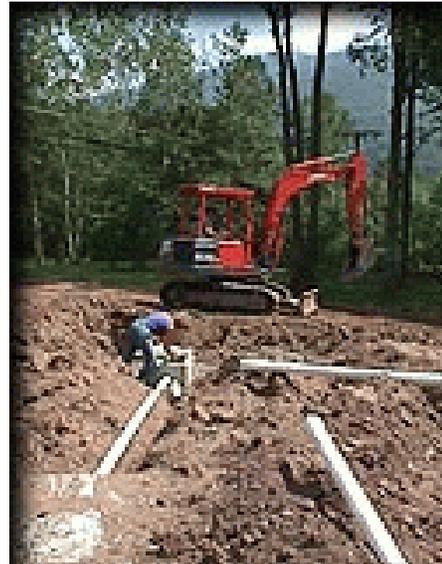
Figure IV-44: Replacement or upgrades of failing septic systems is a high priority of NYCDEP and the Catskill Watershed Corporation(CWC).

Under the 1998 Watershed Partnership and Protection Program, the NYCDEP provided over 6 million dollars in funding through the Catskill Watershed Corporation to replace failing septic systems in the NYC watershed. Initially coordinated in Greene County by the GCSWCD, a large number of failing septic systems were inspected and scheduled for replacement in the Batavia Kill Watershed.

During the time that the GCSWCD coordinated the CWC Septic System Rehabilitation & Replacement Program, inspections of numerous on-site systems in the watershed lead the GCSWCD to predict that as many as 50% of the existing systems may be substandard, in a state of failure, or minimally not working to full effectiveness. To a large degree, this is due to the type of soils present in the watershed as well as the presence of many older systems which pre-date current rules and regulations. A review of the Greene County Soil Survey indicated that over 90% of the soils in the Batavia Kill watershed were characterized by moderate to severe limitations to on-site septic system construction. At the time of this SMP, the CWC funding has been limited to areas outside the Batavia Kill watershed, but it is projected that additional funding may be present in the future to allow for more systems to be replaced.

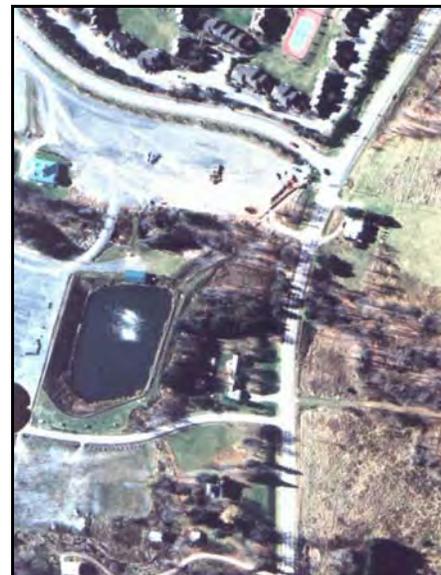
Figure IV-45: Aerial view of a stormwater treatment pond at Ski Windham. The pond captures runoff and provides a controlled release to the stream system.

As the NYC Watershed Rules and Regulations are implemented in the watershed, there has been, and will continue to be, a notable increase in the number of stormwater Best Management Practices (BMPs) constructed in the watershed. Presently, the watershed rules require a Stormwater Pollution Prevention Plan for all development with a disturbance of two acres or more in size. The NYCDEP also requires extensive measures to treat the quality of runoff from new development and to increase mitigation of the rate of runoff. New development in the watershed will require development of retention/detention facilities which would release the stormwater in such a manner that it will not impact the stream hydrology. In some instances, if the NYCDEP requires a landowner to implement BMPs which exceed current state standards, funding may be available from the CWC Stormwater Controls for New Development Program.

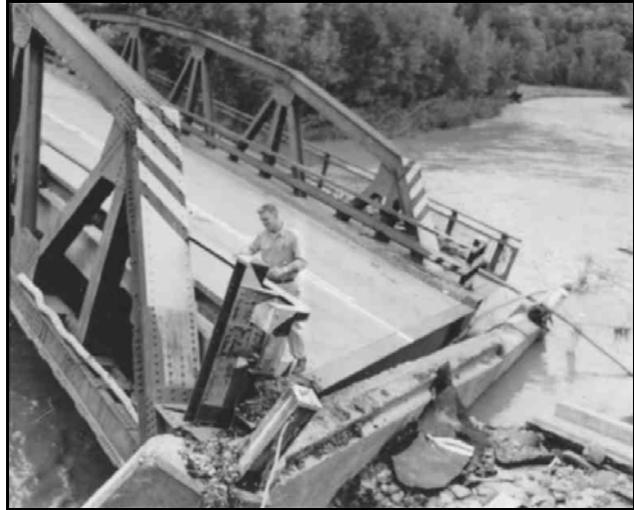
Figure IV-46: Bridges over the Batavia Kill or the tributaries have often been the subject of extensive damage due to flooding.

When bridge crossings are incorrectly sized they can accelerate stream velocity under the bridge, causing severe down cutting of the stream bottom and undermining of the bridge abutments

(Figure IV-46). Unfortunately, the standard mitigation for this type of problem is the installation of a deeper scour wall in front of the eroded abutment which just makes the problem worse. On some older bridges, it is not uncommon to see from 2-4 different scour walls which were poured after flood events damaged the bridge. With each of these incisement activities, the streambed undergoes changes to its profile for some distance upstream and downstream of the bridge, further destabilizing the stream system.
