Broadstreet Hollow Stream Restoration Project

IMPLEMENTATION & MONITORING REPORT

Broadstreet Hollow
Town of Lexington, Greene County, NY

UPDATED
March 2008

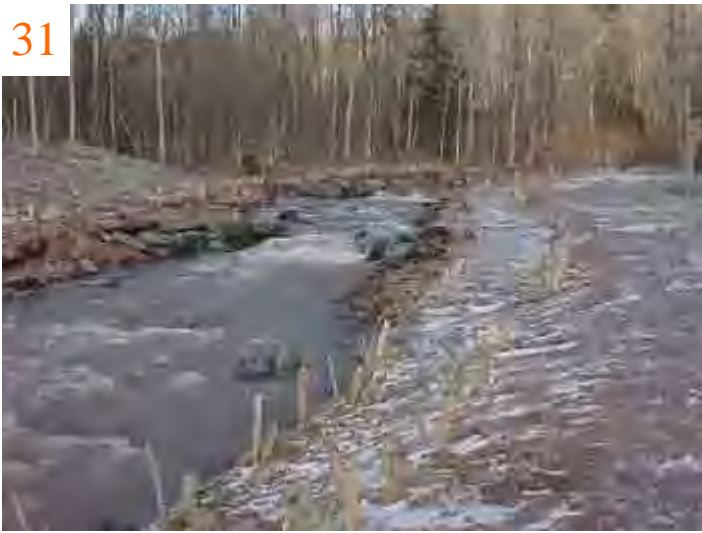
31

December 18, 2000

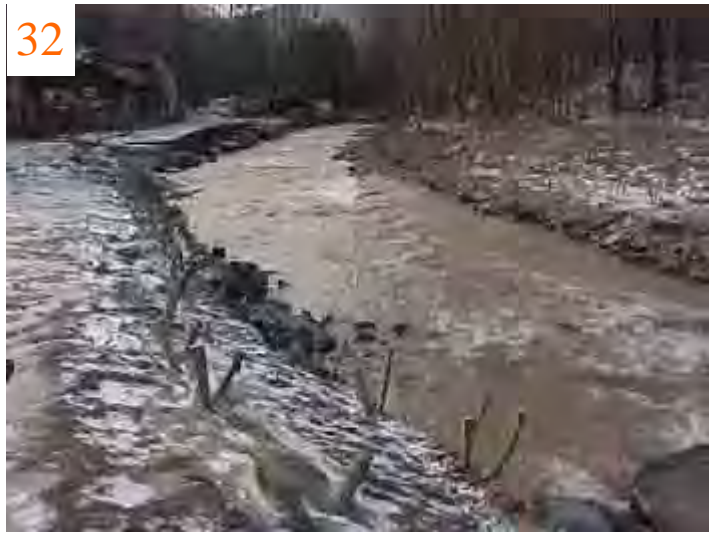
32

December 18, 2000

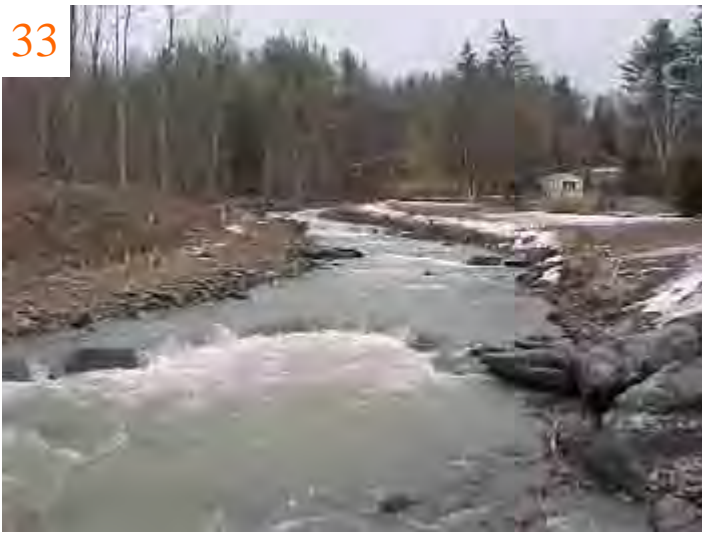
33

April 12, 2001

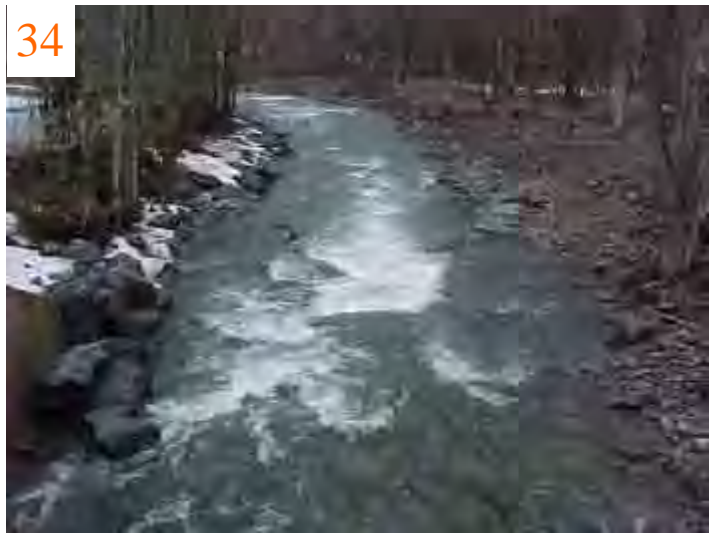
34

April 12, 2001

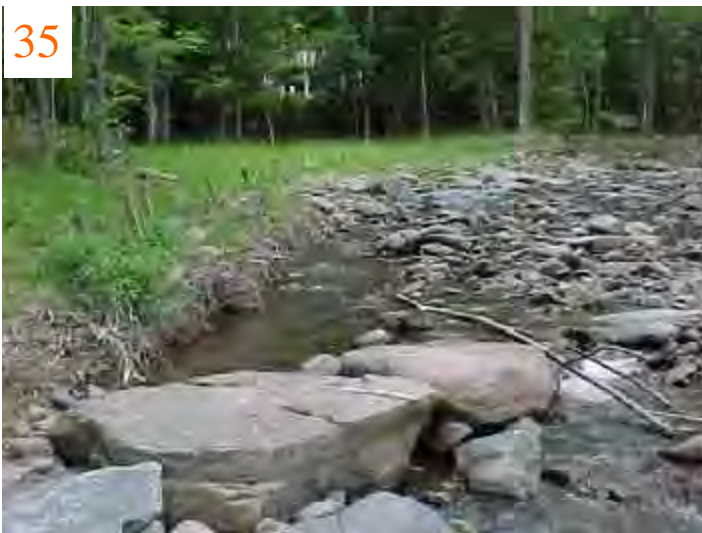
35

July 18, 2001

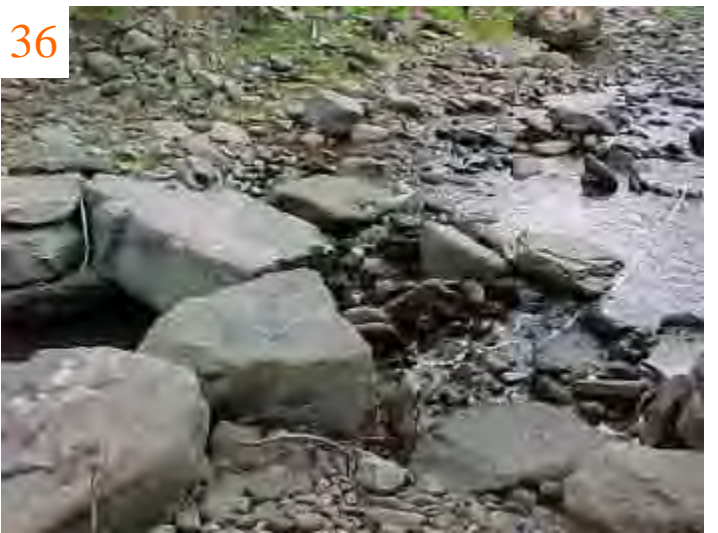
36

July 18, 2001

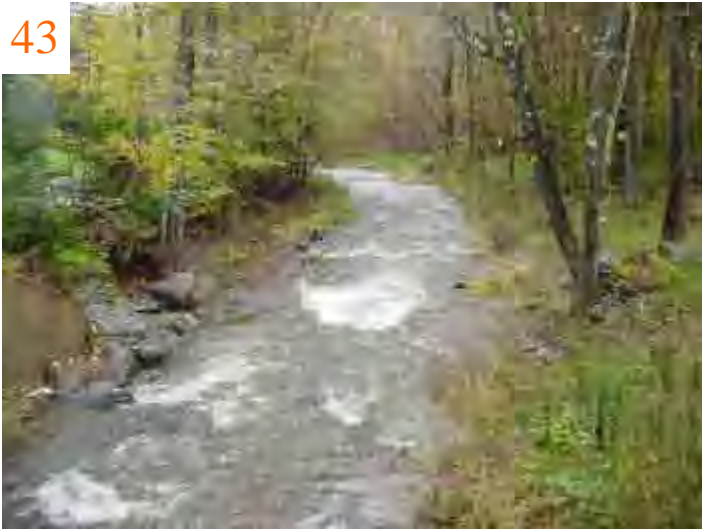
43

October 12, 2002

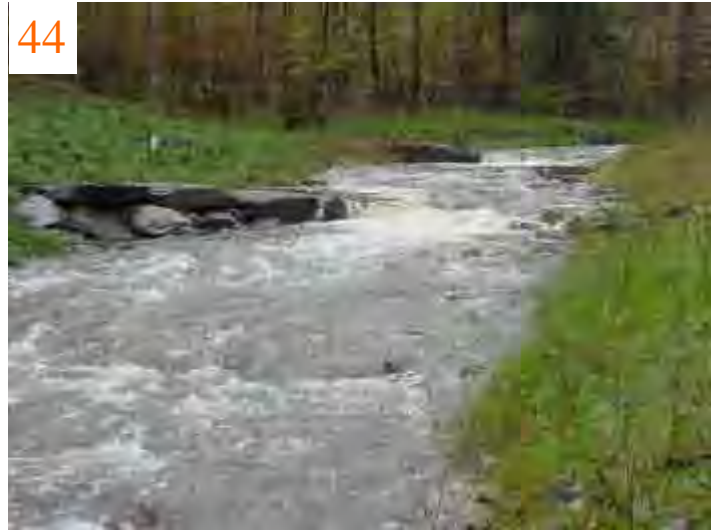
44

October 12, 2002

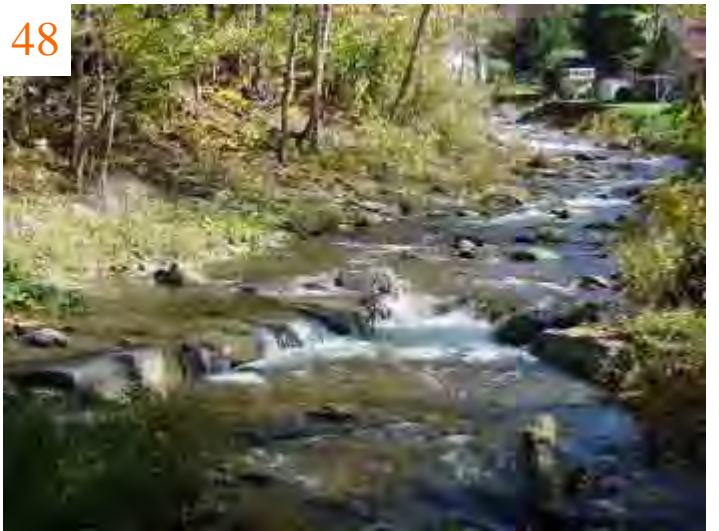
48

- Photograph 48: The lower portion of the project appears to be functioning properly under normal flow conditions.

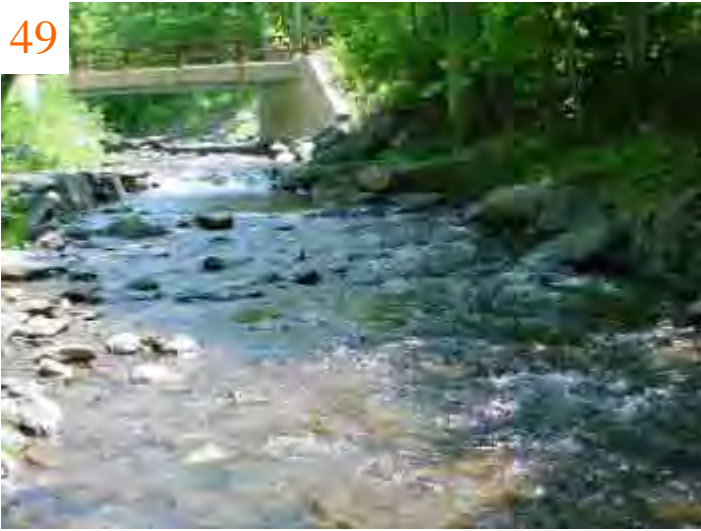
49

- Photograph 49: The upper portion of the reach looking upstream through cross vane #1.
- Photograph 50: The installed vegetation along the right bank continues increase establishment through the upper section of the project.
- Photograph 51: Variation in stream profile, maintained by the cross vane structures, continues to provide physical habitat during low flow periods.
- Photograph 52: A deep scour hole, located below cross vane # 7.
- Photograph 53: The vegetation is slowly increasing establishment along the right bank area, along the face of the former rotational failure.

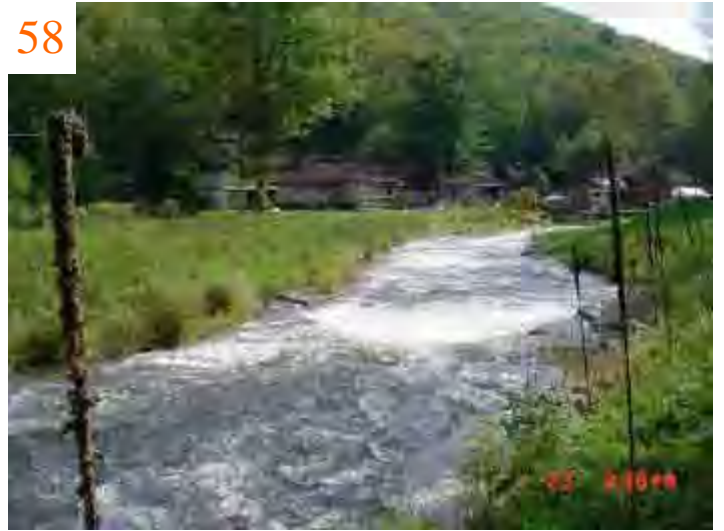
58

Photograph 58: The visual clarity of the water through the entire project area has remained high during moderate increases in stage and stream flow. The photograph views downstream through the area of the previous artesian formation and rotational failure. An inspection of the groundwater relief wells showed that the wells were working properly.

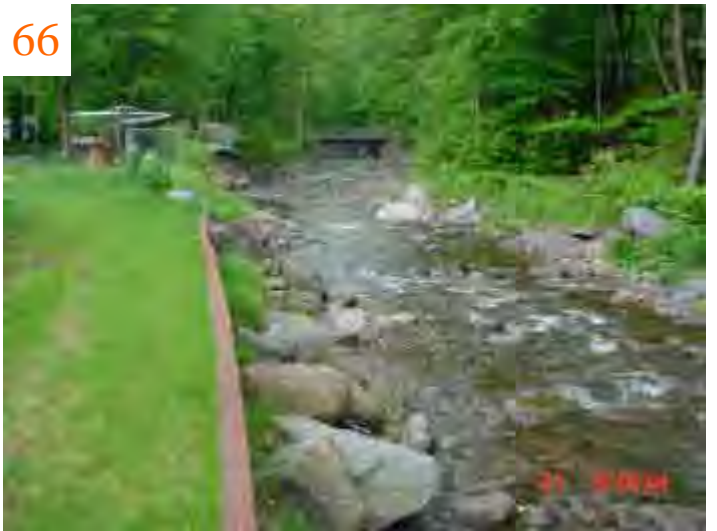
66

Photograph 66: Image looking downstream at lower bridge noting absence of turbid condition during normal flow.

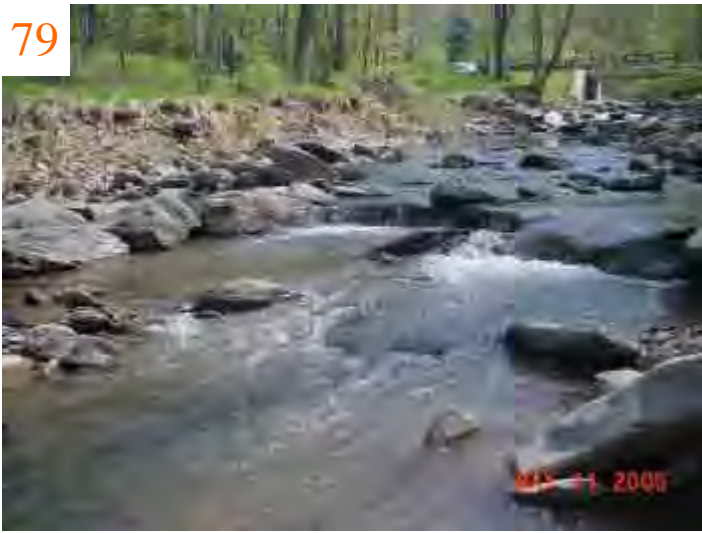
79

- Photograph 79: View looking upstream at upper bridge noting minor right bank scour.
- Photograph 80: Image looking downstream through middle of reach displaying right and left bank erosion and damaged well.
- Photograph 81: Left bank erosion near cross section 4, at fourth downstream cross vane with exposed keyway.
- Photograph 82: Right bank erosion near cross section 5 and exposed well casing.
- Photograph 83: Left bank erosion near cross section 8.
- Photograph 84: Right bank erosion near cross section 8 .

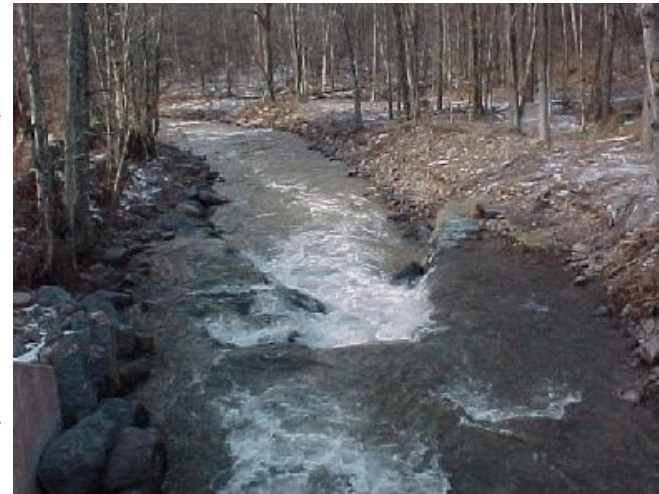
Photo 2. Note still water along banks , velocities in center of the stream channel

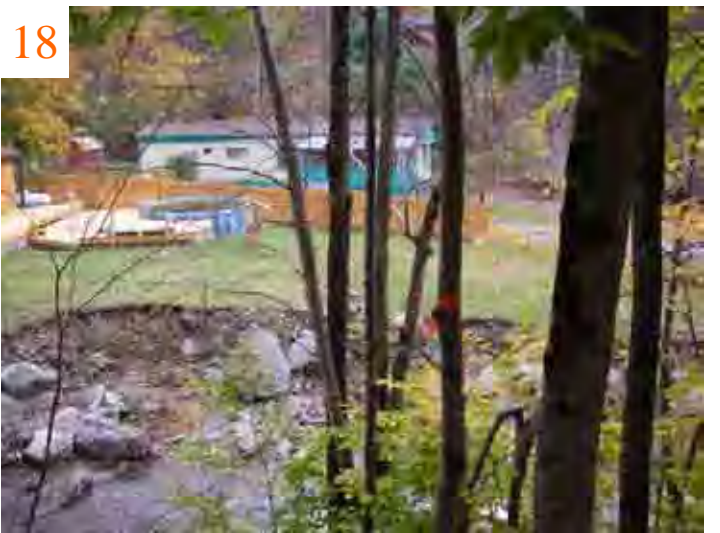
18

- Photograph 18: View from right bank across the stream at cross section 10.
- Photograph 19: Eroded left bank at cross section 10.
- Photograph 20: Downstream view of rip-rap and sheet pile.
